# **PERI Rental Criteria**

## **CB - Climbing system**

Criteria for the evaluation of rental material

Edition: 01/2014

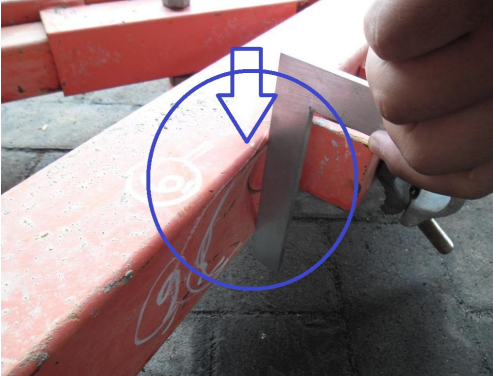
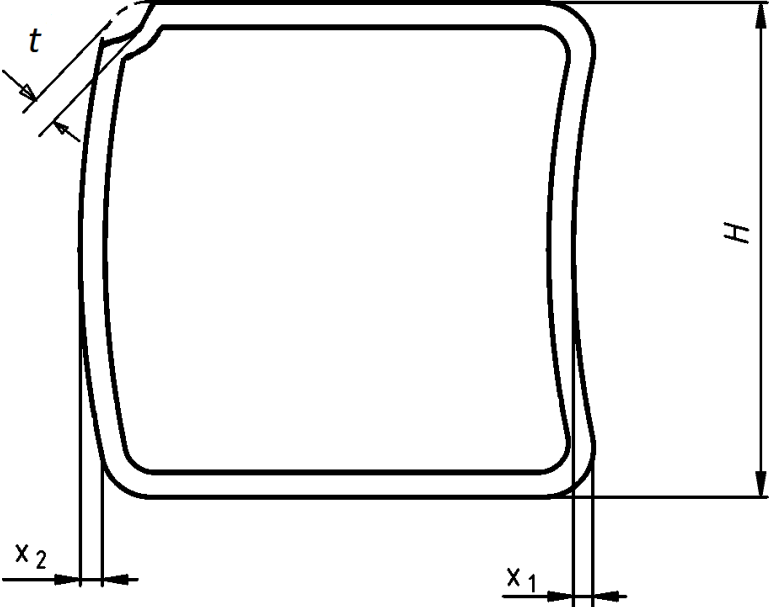
| damage | repair instructions | billing conditions |
|---|---|---|
| <p>11.20.1</p> <ul style="list-style-type: none"> <li>dents or kinks in main frame</li> </ul> <p>dent:<br/> <math>x_1 &gt; H / 25</math>, or<br/> <math>x_1 &gt; 5 \text{ mm}</math></p> <p>bow:<br/> <math>x_2 &gt; H / 25</math>, or<br/> <math>x_2 &gt; 5 \text{ mm}</math></p> | <p>unusable</p> <p>unusable</p> | <p>Sale from rental</p> <p>Sale from rental</p> |

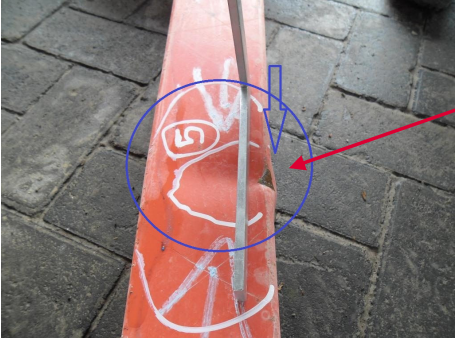
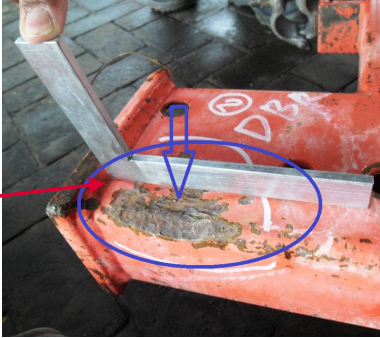
| damage | repair instructions | billing conditions |
|---|---|---|
| <p>11.20.2</p> <ul style="list-style-type: none"> <li>damage in edge</li> </ul> <p>dent in edge<br/> <math>t &gt; H / 25</math>, or<br/> <math>t &gt; 5 \text{ mm}</math><br/> (H is the smaller measure of width and height of the hollow profile)<br/> edge with surface area damaged<br/> length <math>&gt; 15 \text{ mm}</math></p> | <p>11.20.2<br/> damage in edge – unusable</p> <p>11.20.2<br/> edge with large surface area damaged - unusable</p> <p>unusable</p> <p>unusable</p> | <p>Sale from rental</p> <p>Sale from rental</p> |

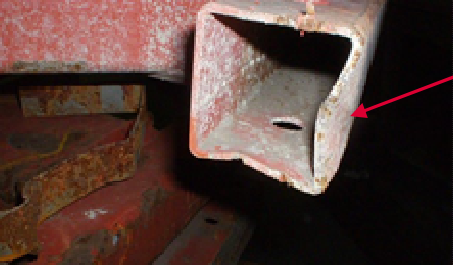
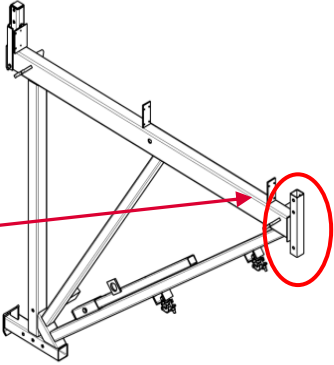
| damage | repair instructions | billing conditions |
|--|---|--|
| <p>11.20.3</p> <ul style="list-style-type: none"> <li>Fixing handrail holder bent</li> </ul> | <p>11.20.3<br/>handrail holder bent - unusable</p> <p>11.20.3<br/>handrail holder</p> | |
| <p>dent <math>x_1 &gt; 2</math> mm</p> | <p>unusable</p> | <p>Sale from rental</p> |

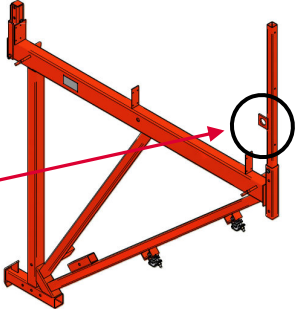
| damage | repair instructions | billing conditions |
|--|---|--|
| <p>11.20.4</p> <ul style="list-style-type: none"> <li>load bearing point of handrail holder CB 240</li> </ul> <p>ear deformed or cracks in welding seam</p> | <p>11.20.4<br/>load bearing point of handrail holder CB 240</p> <p>repair not possible<br/>replace handrail holder CB 240<br/>item no.: 715977</p> | <p>spare part</p> |

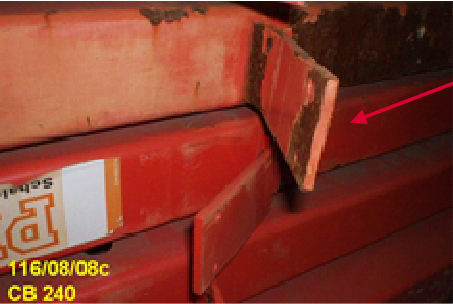
| damage | repair instructions | billing conditions |
|--|---|--|
| <p>11.20.5</p> <ul style="list-style-type: none"> <li>fixing lug CB 240 bent</li> </ul> <p>lug slightly bent <math>&lt; 20^\circ</math></p> <p>lug badly bent <math>&gt; 20^\circ</math>, welding seam or lug cracked or lug missing</p> | <p>11.20.5<br/>fixing lug badly bent – if applicable remove old lug and weld on new lug</p> <p>11.20.5<br/>fixing lug CB 240</p> <p>cold repair, ATTENTION to cracks!</p> <p>if applicable remove old lug and weld on new lug item no. 701222</p> | <p>working time</p> <p>working time + spare part</p> |

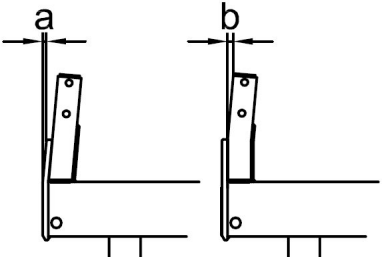
| damage | repair instructions | billing conditions |
|--|---|---|
| <p><b>11.20.6</b></p> <p>▪ <b>end plate damaged</b></p> <p>CB 240/160 end plate dent<br/>a &gt; 1 mm</p> <p>CB 240 pin to hand rail dent<br/>b &gt; 5 mm</p> <p>other damages or dents on end plate</p> | <p><b>11.20.6</b><br/>connection to carriage<br/>and end plate</p> <p>unusable</p> <p>unusable</p> <p>unusable</p> | <p>sale from rental</p> <p>sale from rental</p> <p>sale from rental</p> |

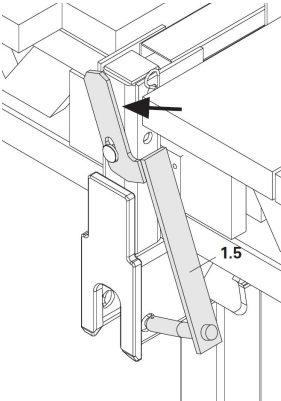
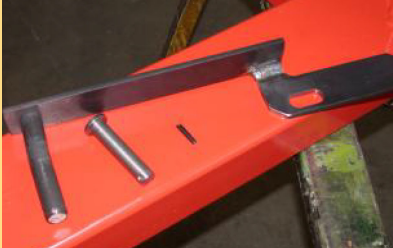
| damage | repair instructions | billing conditions |
|--|---|---|
| <p>11.20.9</p> <p>▪ <b>Check functionality: safety bolt CB 240</b></p> <p>safety unit not rotatable or welding seam cracked</p> <ul style="list-style-type: none"> <li>- safety lock powder-coated</li> <li>- safety bolt <math>\varnothing</math> 16mm</li> <li>- sleeve 5x26</li> </ul> | <p>replace missing or damaged parts as per modification instruction IQM 2006/049:</p> <p>Item no. 111148<br/>Item no. 111147<br/>Item no. 721925</p> | <p>spare parts<br/>+ working time</p> |

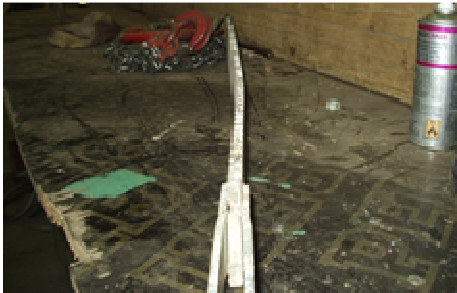
| damage | repair instructions | billing conditions |
|--|---|---|
| <ul style="list-style-type: none"> <li>▪ <b>rack CB 240 dent</b></li> </ul> <p>e &gt; L [mm] / 200</p> | <p>unusable</p> | <p>Sale from rental</p> |

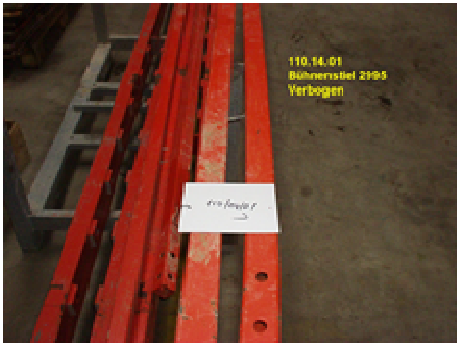
| damage | repair instructions | billing conditions |
|--|---|---|
| <b>11.20.15</b><br><ul style="list-style-type: none"> <li>platform shaft 225 bent</li> </ul> <p>e &gt; L [mm] / 200</p> | unusable | Sale from rental |

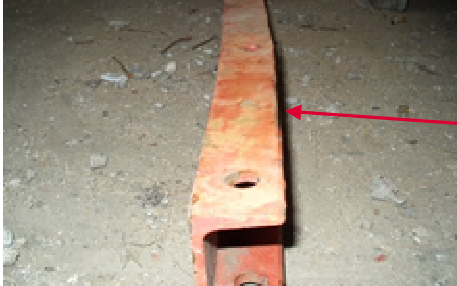
| damage | repair instructions | billing conditions |
|---|---|---|
| <b>11.20.20</b><br><ul style="list-style-type: none"> <li>handrail shaft 190 and 370, bent</li> </ul> <p><math>e &gt; L \text{ [mm]} / 200</math></p> | <b>11.20.21</b><br>Handrail shaft bent<br>$e > L \text{ [mm]} / 200$ - unusable<br><br>unusable | Sale from rental |

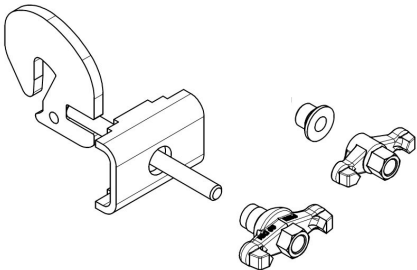
| damage | repair instructions | billing conditions |
|--|---|---|
| <b>11.20.24</b><br><ul style="list-style-type: none"> <li>check completeness:<br/> <b>Bolt holder U 100-U120</b> <ul style="list-style-type: none"> <li>bolt holder</li> <li>cross strap</li> <li>spherical nut RD 16</li> </ul> </li> </ul> <p>damaged thread at old version with cross strap and drill Ø18</p> | replace missing or damaged parts:<br>Item no. 110058<br>Item no. 110055<br>Item no. 118260<br><br>consider PM-Memo 2010-39:<br>new version cross strap with drill Ø30.5 only for use with spherical nut or alternatively with wing nut RD16x1/8" (Item no. 710264) and spherical sleeve Ø17 (Item no. 118291) | spare parts<br>+ working time |
| damaged thread at old version with cross strap and drill Ø18 | repair as per PM-Memo 2010-39 | no charging |

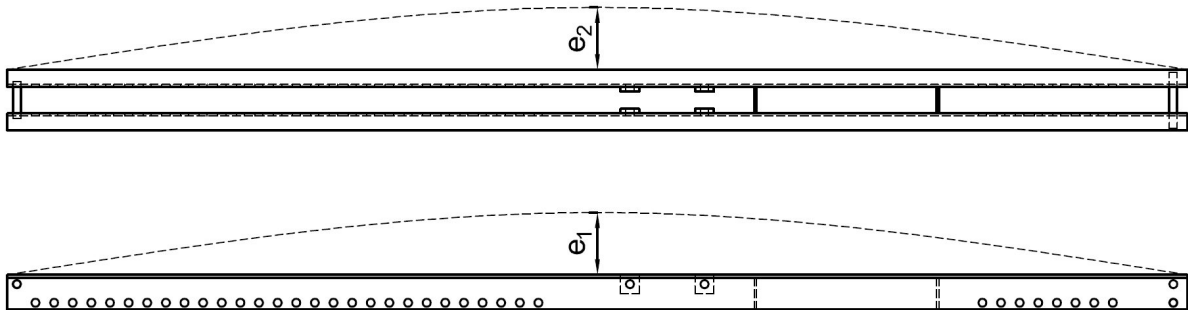
| damage | repair instructions | billing conditions |
|---|---|---|
| <b>11.20.29</b><br><ul style="list-style-type: none"> <li>Strongback bent</li> </ul> | | |

| Strongback 270 and 380<br>$e_1 > 5 \text{ mm}$<br>$e_2 > 8 \text{ mm}$ | repair not possible<br>unusable | Sale from rental |
