# PERI Rental Criteria

## GT 24 Girder

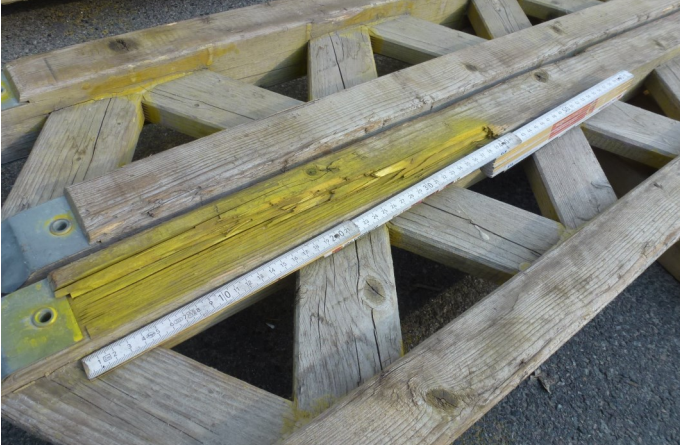
<b>Splintering at the chord</b> <ul style="list-style-type: none"> <li>■ <math>\leq 33</math> mm width</li> <li>■ and <math>\leq 35</math> cm length</li> </ul>

<ul style="list-style-type: none"> <li>■ Or <math>&gt; 35</math> cm length</li> <li>■ and <math>\leq 10</math> mm width</li> </ul>

<ul style="list-style-type: none"> <li>■ Or <math>&gt; 10</math> mm width</li> </ul>

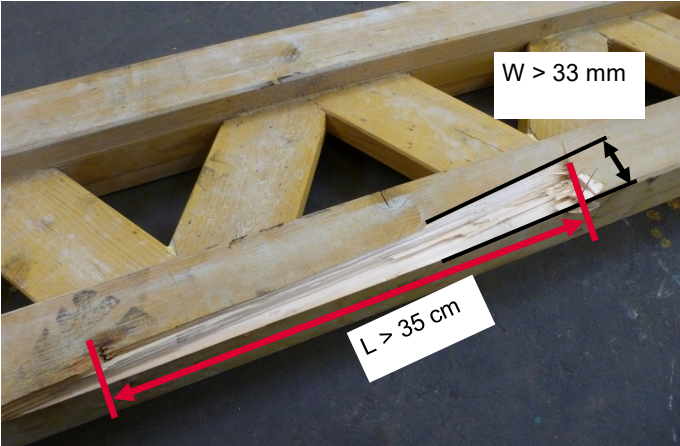
<b>Splintering at the chord</b> <ul style="list-style-type: none"> <li>■ <math>&gt; 33</math> mm width</li> </ul>

<ul style="list-style-type: none"> <li>■ Or <math>&gt; 35</math> cm Length</li> <li>■ and <math>&gt; 10</math> mm width</li> </ul>

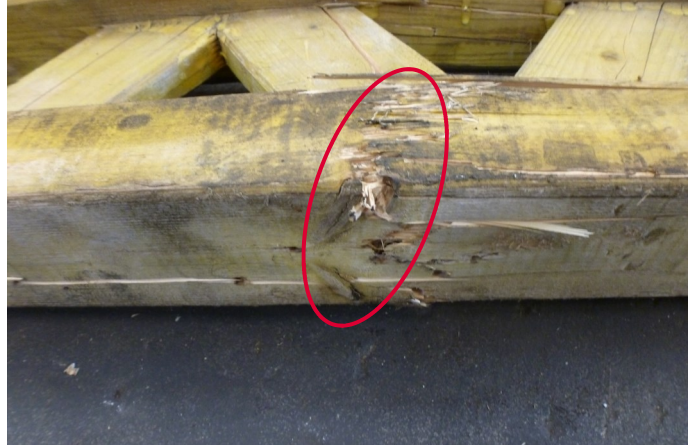
<p><b>Break of the chord</b></p> <ul style="list-style-type: none"> <li>■ Break caused by overloading</li> </ul>

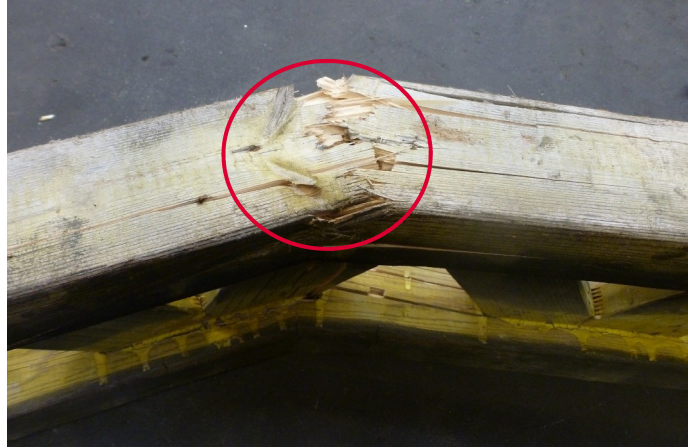
<p><b>Break across the grain</b></p>

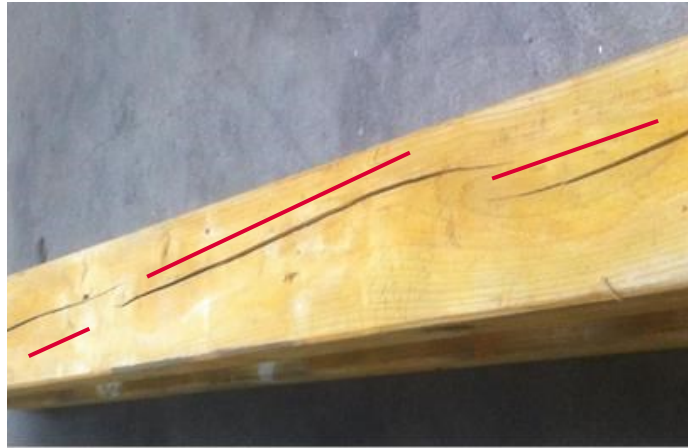
<p><b>Shrinkage caused by drying out</b></p> <ul style="list-style-type: none"> <li>■ Crack along the grain</li> <li>■ and no continuous crack</li> <li>■ and max. width <math>\leq 4</math> mm</li> <li>■ and max. length 1 m</li> </ul>

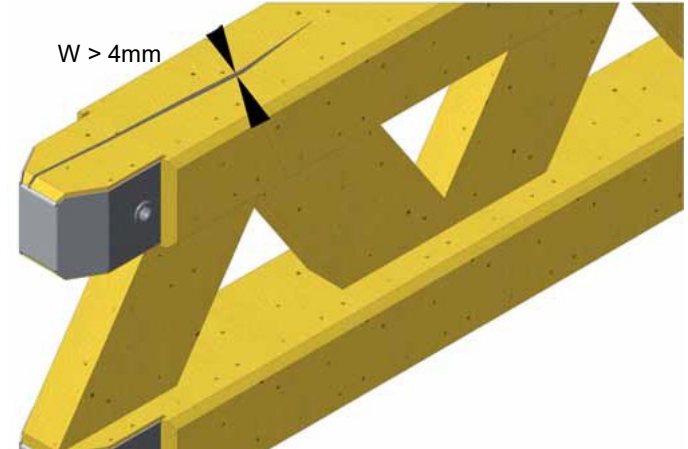
<p><b>Shrinkage crack</b></p> <ul style="list-style-type: none"> <li>■ Width <math>&gt; 4</math> mm</li> <li>■ Length <math>&gt; 1</math> m</li> </ul>	<p>

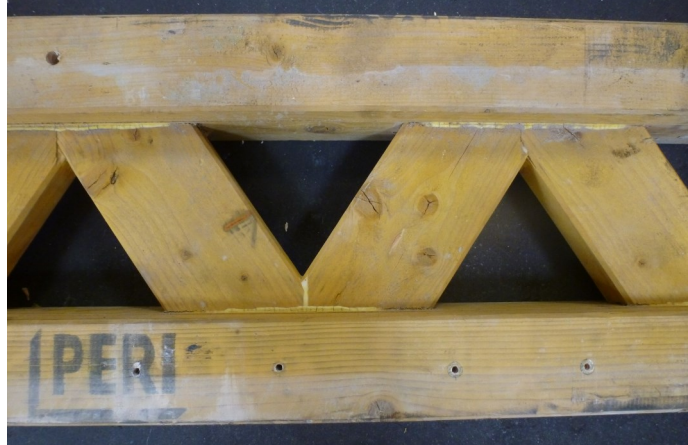
<p><b>Holes <math>\varnothing \leq 4</math> mm</b></p> <ul style="list-style-type: none"> <li>■ Max. 4 holes axial (in one line)</li> <li>■ and minimum distance 80 mm</li> <li>■ and distance to next drill holes &gt; next knot pattern</li> </ul>

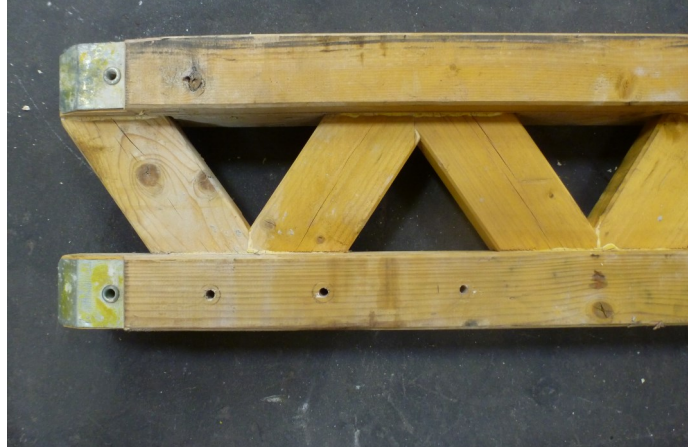
<p><b>Holes <math>\varnothing \leq 8</math> mm at the end of the girder</b></p> <ul style="list-style-type: none"> <li>■ Max. 3 holes axial (in one line)</li> <li>■ and minimum distance 80 mm</li> <li>■ and distance to next drill hole &gt; next knot pattern</li> </ul>

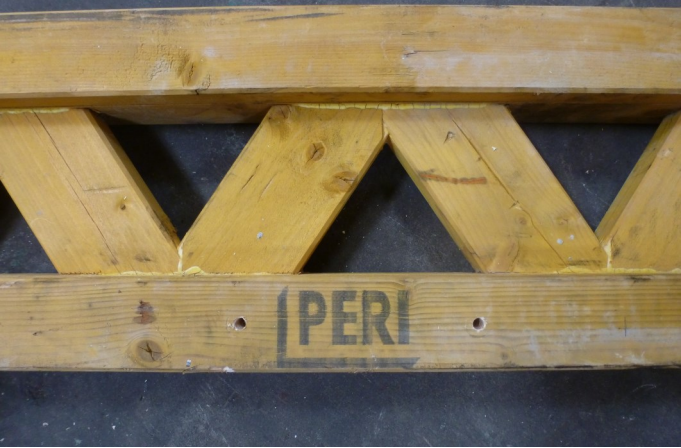
<b>Holes <math>\varnothing \leq 8</math> mm</b> <ul style="list-style-type: none"> <li>Max. 2 holes axial (in one line) and minimum distance 142 mm and distance to next drill hole &gt; next knot pattern</li> </ul>

<ul style="list-style-type: none"> <li>Or more than 2 holes</li> <li>Or distance to next hole &lt; 142mm</li> </ul>

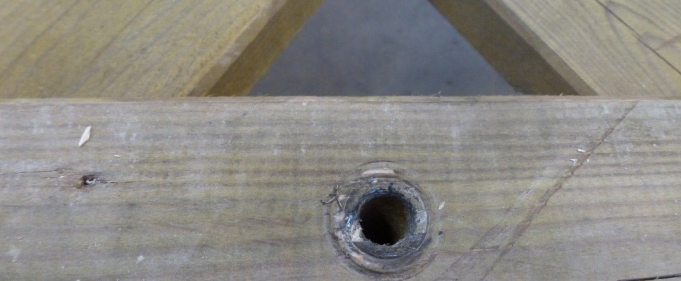
<b>Holes <math>\varnothing \leq 12</math> mm in Chord</b> <ul style="list-style-type: none"> <li>Max. 1 hole between knot pattern</li> </ul>

<ul style="list-style-type: none"> <li>Or more than one hole each knot pattern</li> </ul>

<ul style="list-style-type: none"> <li>Or &gt;12 mm <math>\varnothing</math></li> </ul>

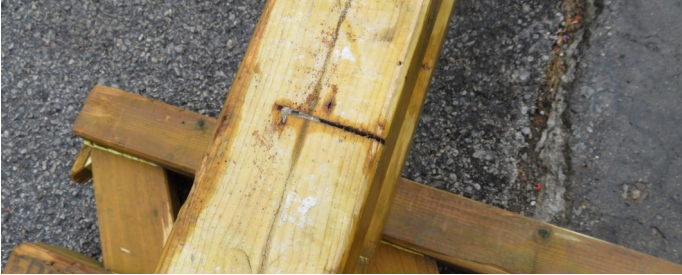
<b>Cut in chord</b> <ul style="list-style-type: none"> <li>■ Depth <math>\leq 2</math> mm between knot pattern</li> </ul>

<ul style="list-style-type: none"> <li>■ Or <math>d &gt; 2</math> mm</li> </ul>

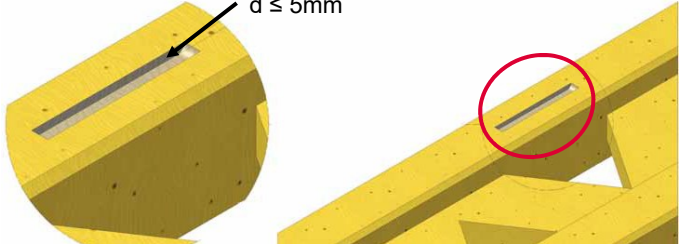
<b>Cut in chord</b> <ul style="list-style-type: none"> <li>■ cut along the grain <math>\leq 5</math> mm</li> <li>■ and max. 1 between knot patterns</li> </ul>

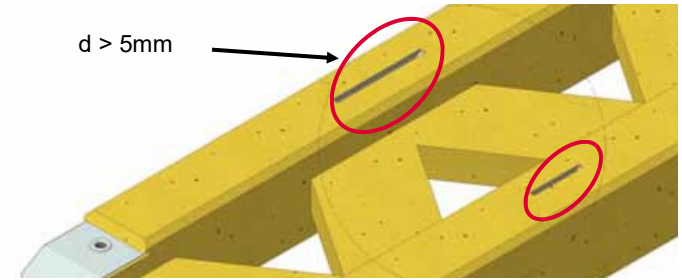
<b>Cut in chord</b> <ul style="list-style-type: none"> <li>■ Cut along the grain <math>\leq 5</math> mm</li> <li>■ and more than one cut between knot patterns</li> </ul>

<ul style="list-style-type: none"> <li>■ Or depth <math>&gt; 5</math> mm</li> </ul>

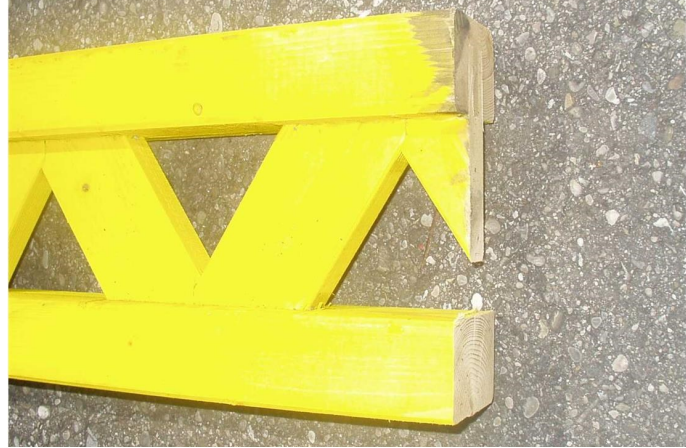
<p><b>Girder cut not according to PERI standard</b></p>	<p>

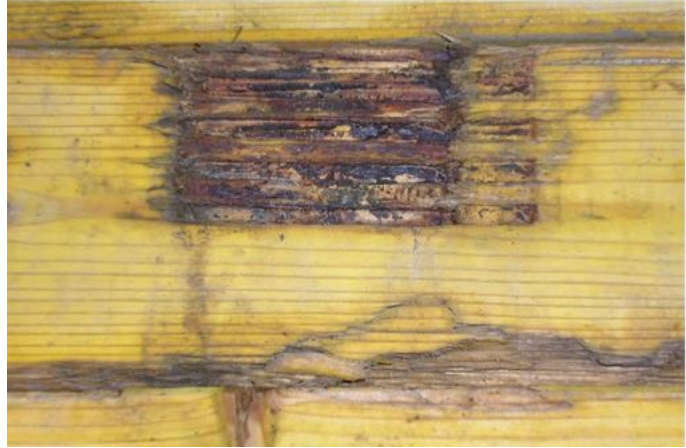
<p><b>Chord damaged by concrete vibrator</b></p> <ul style="list-style-type: none"> <li>■ Pressure marks <math>\leq 3,0</math> mm</li> <li>■ Or pressure marks <math>&gt; 3,0</math> mm</li> </ul>	<p>

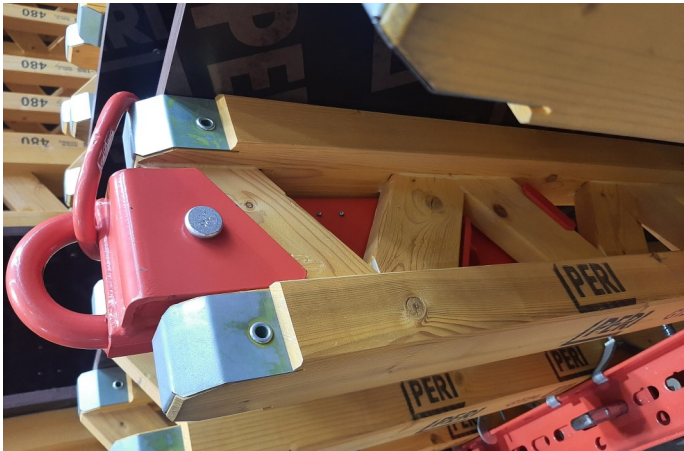
Crane Splice can't be assembled due to incorrect shortening (Pictures shows correct assembly)

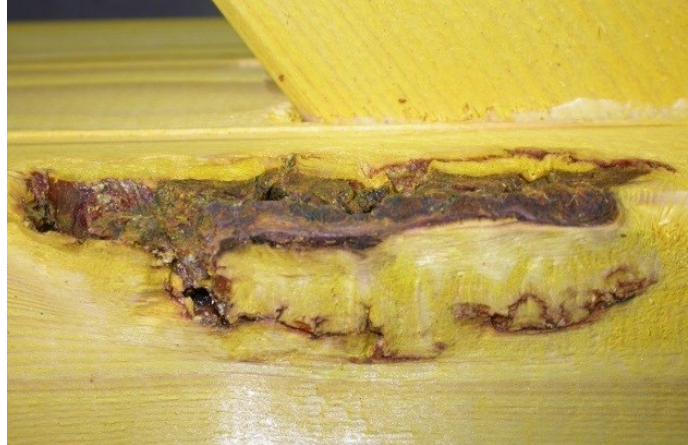
<p><b>Intergrowth of bark</b></p>

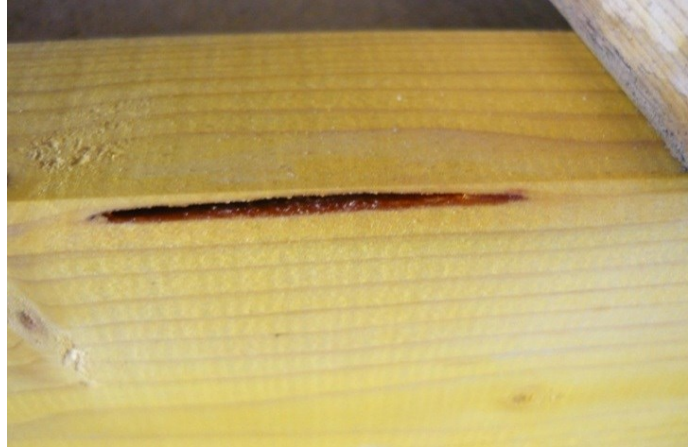
<p><b>Resin inclusion</b></p> <ul style="list-style-type: none"> <li>■ ≤ 5 mm</li> </ul>

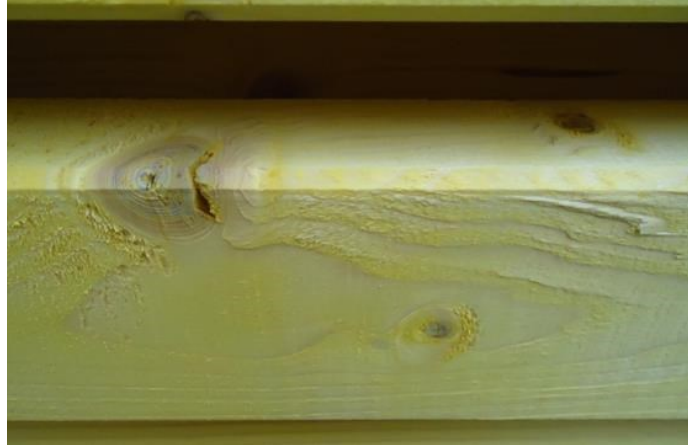
<p>Knot in the girder edge</p>

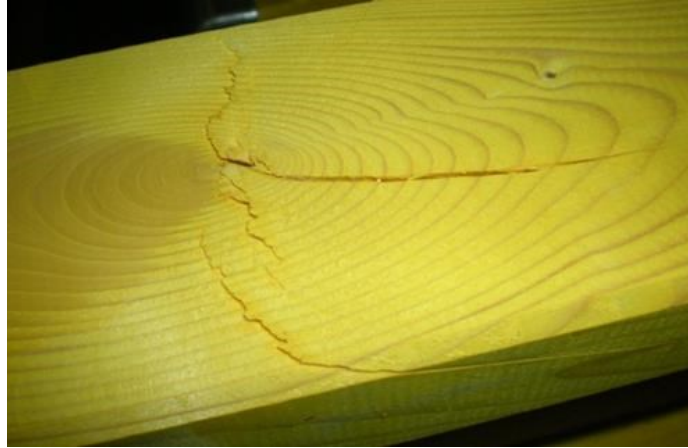
<p>Round break</p>

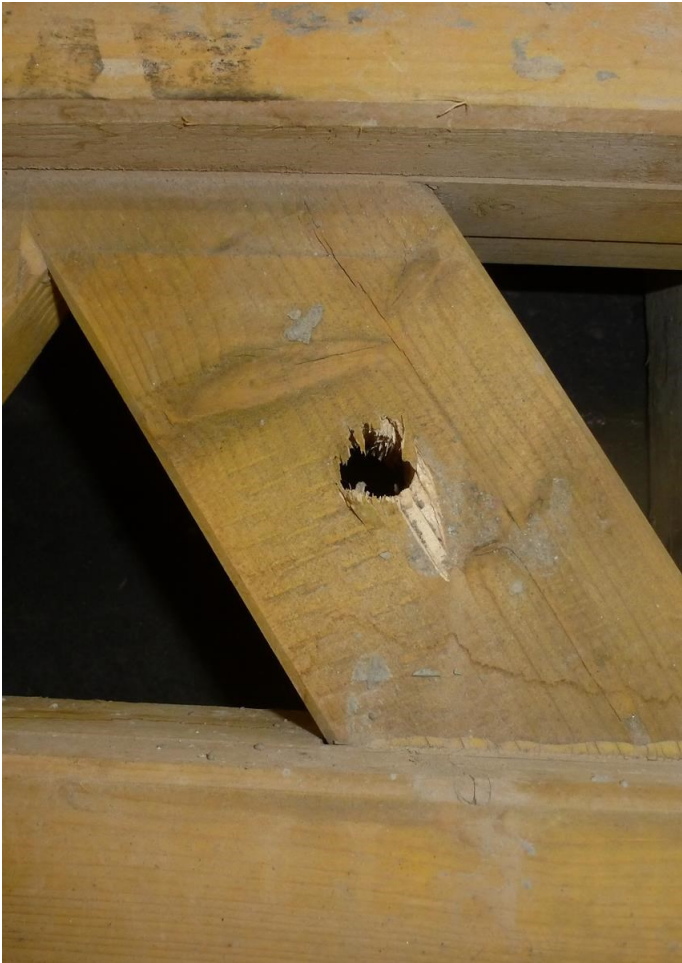
**Hole in brace**

- $\leq \text{Ø } 18 \text{ mm}$
- and max. one hole in brace

- Hole  $\leq \text{Ø } 18 \text{ mm}$
- and more than one hole in brace

- Or  $> \text{Ø } 18\text{mm}$

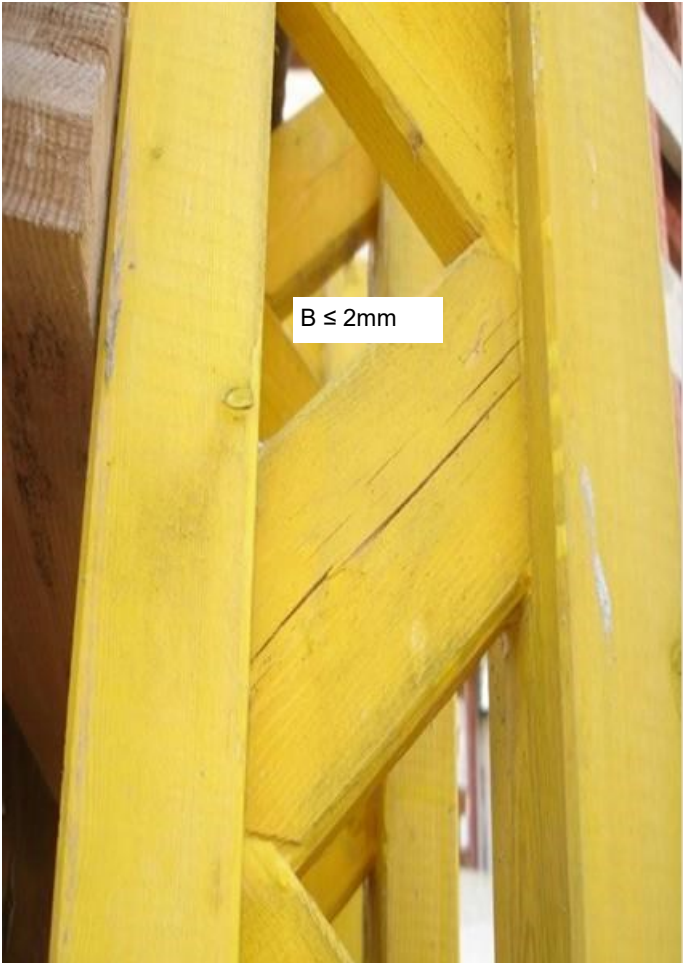
**Crack in brace**

- crack vertical to grain

- Or crack along the grain  $\leq 2$  mm

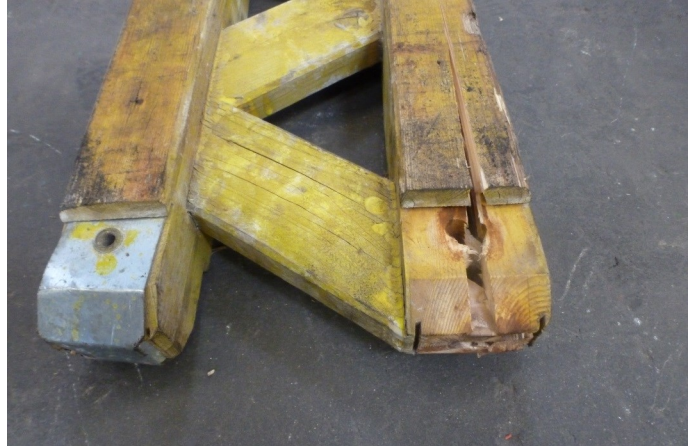
<b>Cap end broken</b>			
	<ul style="list-style-type: none"> <li>■ with new cap (rivet through wood)</li> </ul>

<ul style="list-style-type: none"> <li>■ Or with old cap</li> </ul>

<ul style="list-style-type: none"> <li>■ Or with old cap</li> <li>■ and splintering &gt; 33 mm</li> </ul>
