PERI Rental Criteria

VRB Heavy-Duty Truss Girder

Content	Page
Supporting frame	2
VRB Supporting frame VRB	5
Coupling frame	8
Standard frame VRB	11
Horizontal bearing	14
Bracing connection VRB	15
Vertical brace connection	16
Main beam VRB	17
Horizontal Bearing-2	18

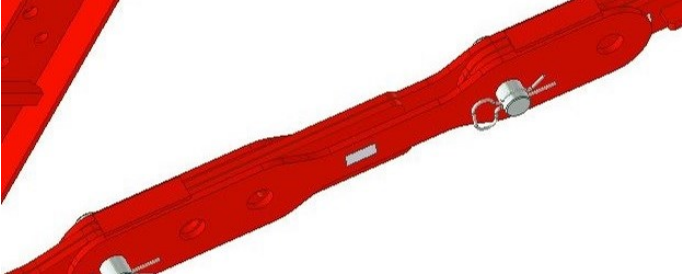
Tendon (126547)

Tendon bent / defect

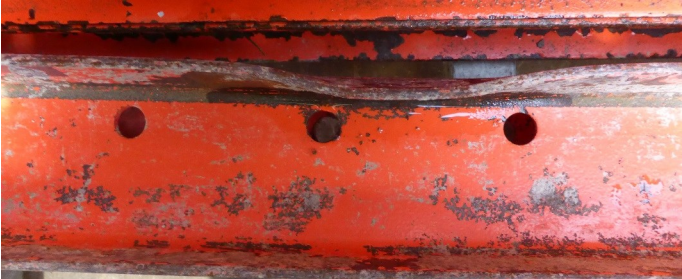
Dent on the top and bottom flanges

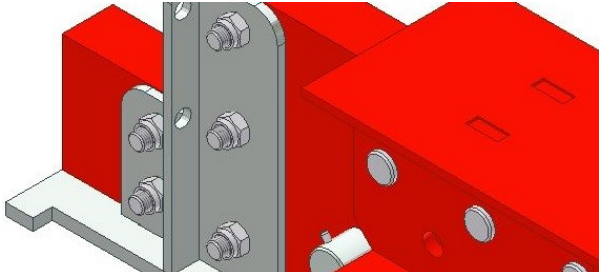
„Teleskopkastenschuh“ (128084)

„Teleskopkastenschuh“ bent / ripped

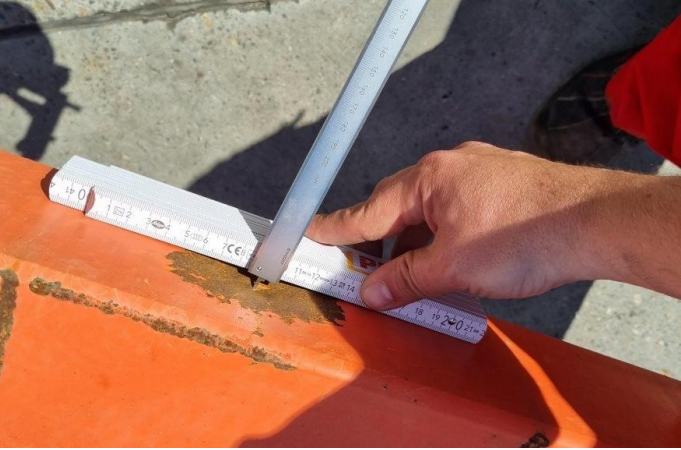
Dent in tube <ul style="list-style-type: none"> ■ ≤ 10 mm depth and edges of tube not affected

<ul style="list-style-type: none"> ■ Or > 10 mm depth

<ul style="list-style-type: none"> ■ Or edges of tube affected

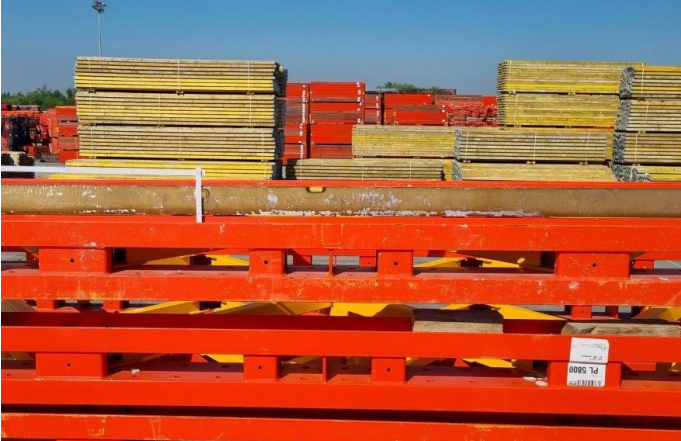
Chord bent <ul style="list-style-type: none"> ■ $\leq 1/500$

<ul style="list-style-type: none"> ■ Or $> 1/500$

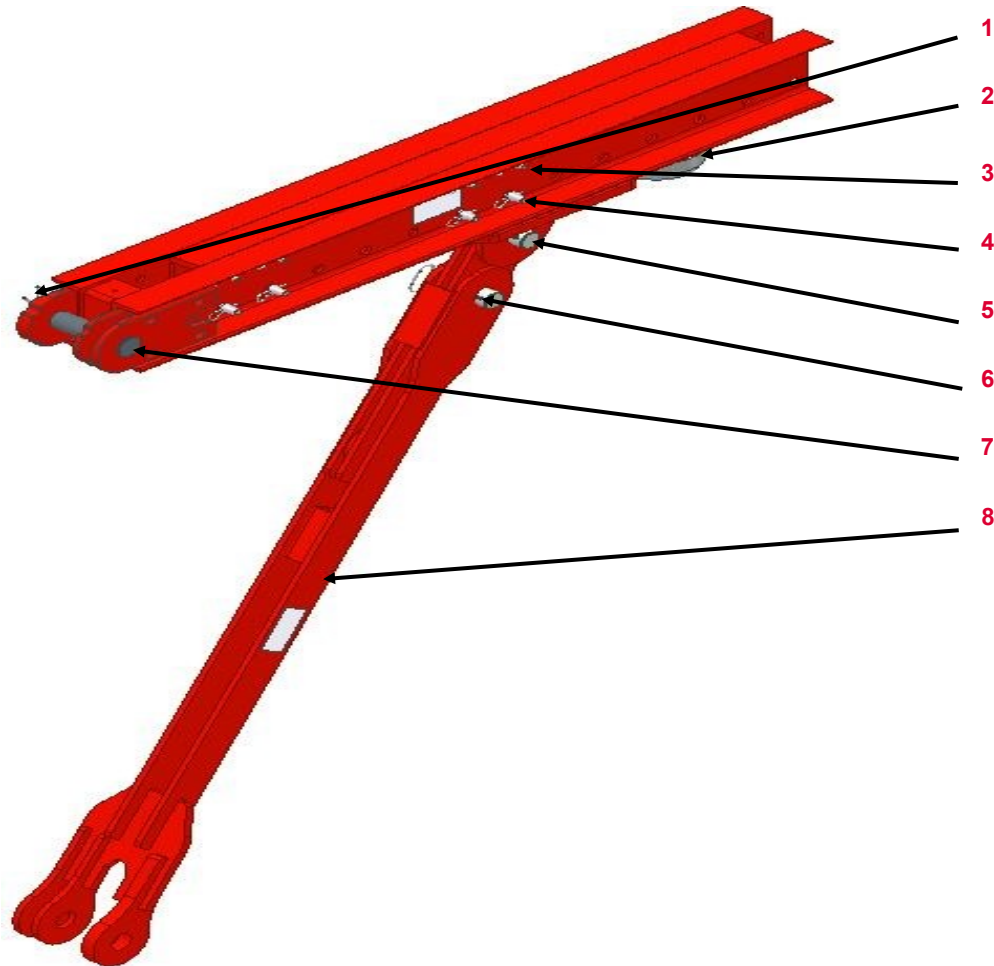
Supporting frame VRB (125152)

No.	Description	Article number
1	Cotter pin 6-1	125356
2	Calotte	125446
3	Fit bolt 21x105	125349
4	Fit bolt 26x105	125345
5	Bolt	113625
6	Dowel pin	770013
7	Bolt	125356
8	Pull bar bearing	125179

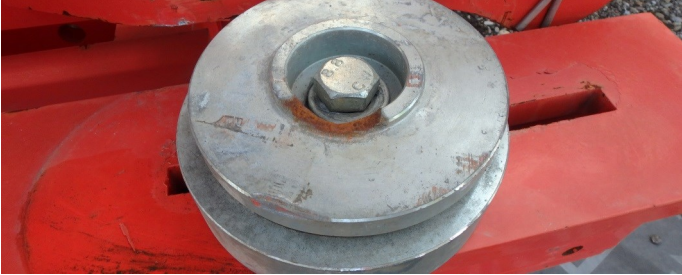
Calotte (125446)

Broken calotte

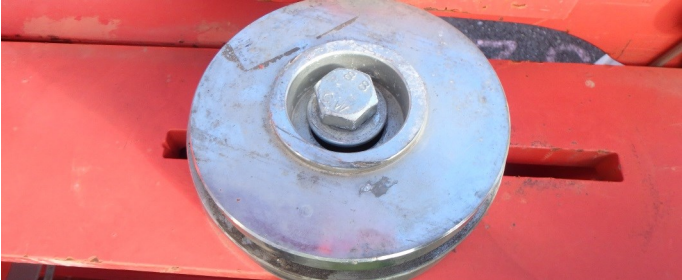
Calotte (125446) 	<ul style="list-style-type: none">

Calotte no longer functional	<ul style="list-style-type: none"> ■ If possible

Lubricate afterwards ■ Or if not possible

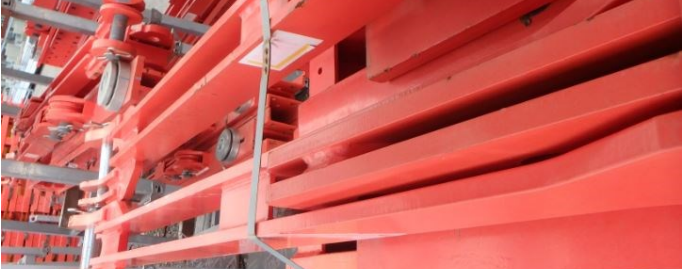
Pull bar (125179)

Pull bar bent

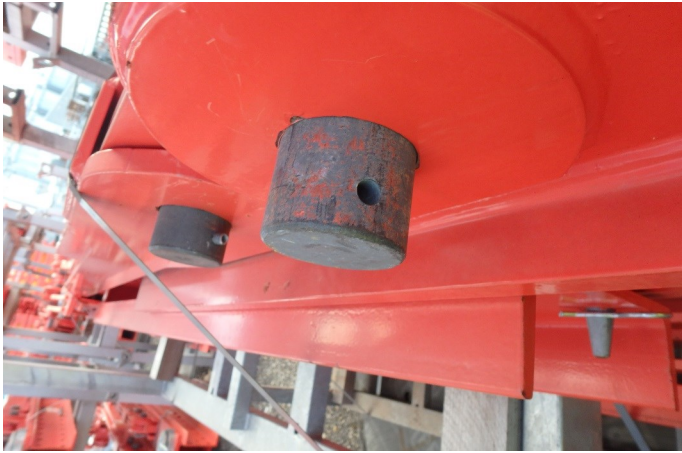
Bolts / Cotter pins / Dowel pins missing

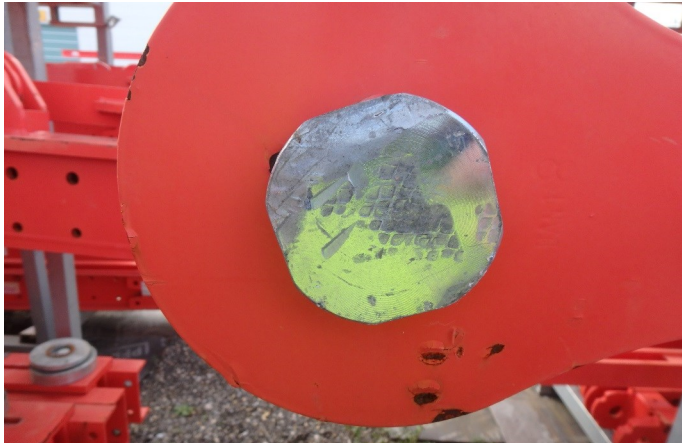
Bolt(125356)

Deformed bolts <ul style="list-style-type: none"> ■ Without rips in the material ■ Or with rip in the material

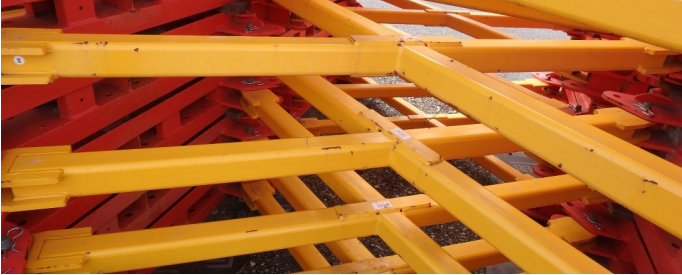
Diagonal brace(125409)

Diagonal brace bent / broken

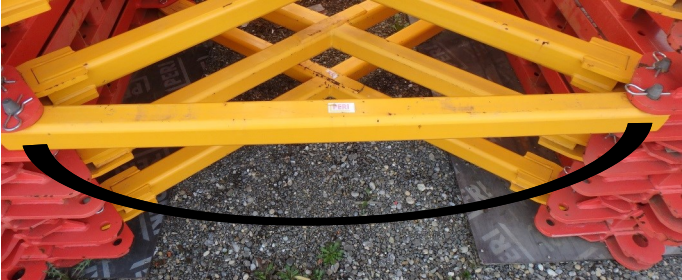
„Druckpfosten“ (125413)

„Druckpfosten“ bent / broken ■ > 3,0 mm (l/500)

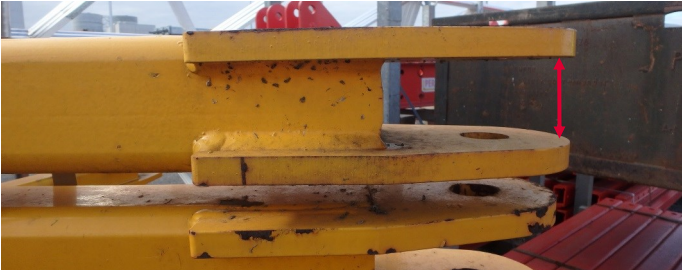
Connection of the „Druckpfosten“ is bent

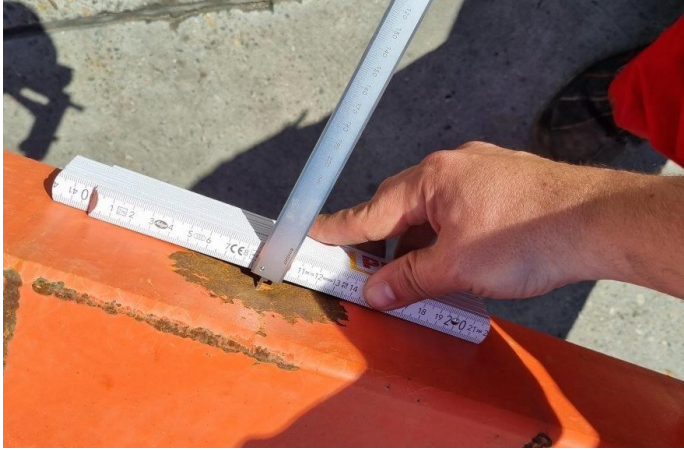
<p>Dent in tube</p> <ul style="list-style-type: none"> ■ ≤ 10 mm depth and edges of tube not affected ■ Or > 10 mm depth ■ Or edges of tube affected 	<ul style="list-style-type: none"> ■

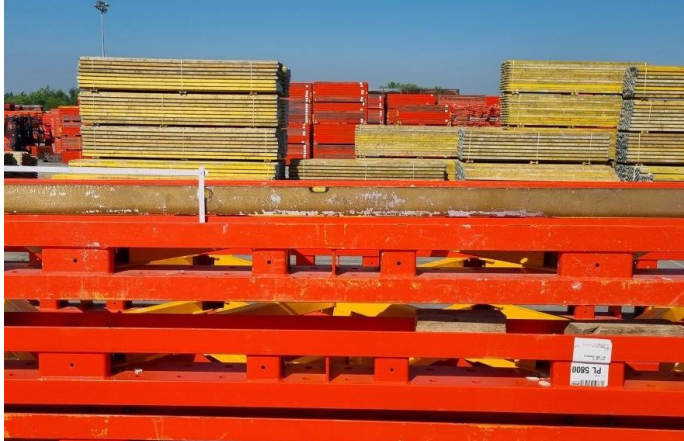
<p>Chord bent</p> <ul style="list-style-type: none"> ■ $\leq 1/500$ ■ Or $> 1/500$ 	<ul style="list-style-type: none"> ■

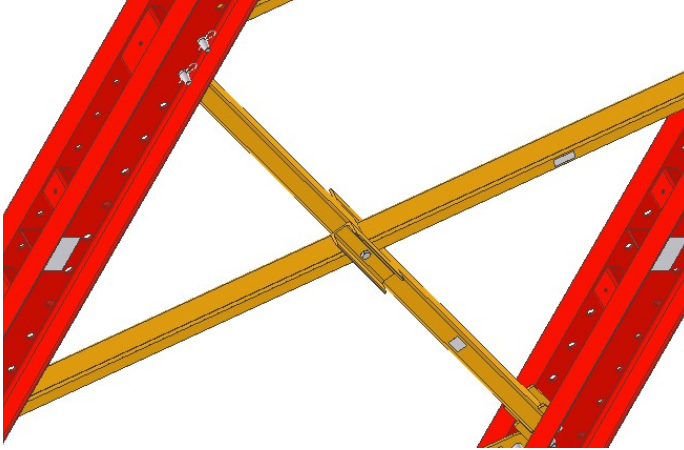
<p>Diagonal continuous (125381) Diagonal discontinuous (125371)</p>

<p>Diagonals bent</p> <ul style="list-style-type: none"> ■ L > 5 mm (l/500)

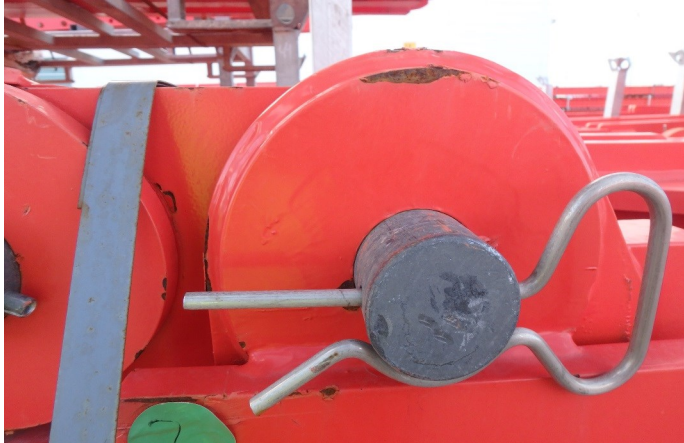
<p>Bolt Cotter pin Dowel pin is missing</p>

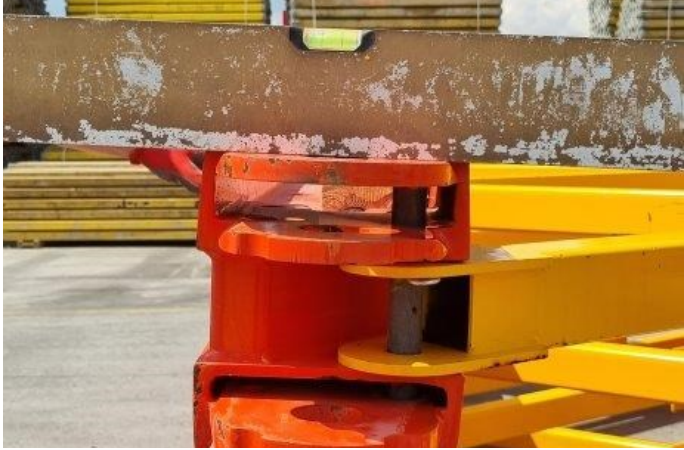
<p>Connector bent</p> <ul style="list-style-type: none"> ■ Assembly possible ■ Or assembly not possible 	<ul style="list-style-type: none">

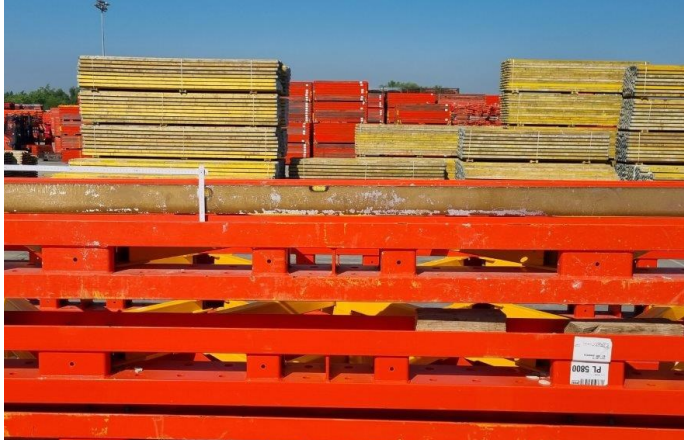
<p>Chord bent</p> <ul style="list-style-type: none"> ■ $\leq 1/500$ ■ Or $> 1/500$ 	<ul style="list-style-type: none">

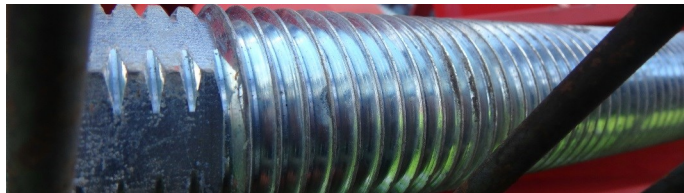
Threaded bar

- Soiled
- Or bent

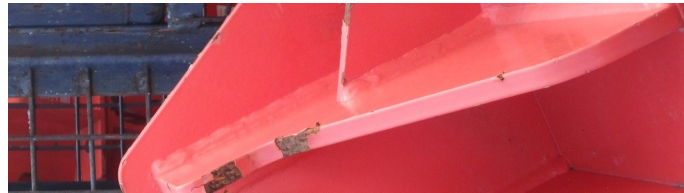
Base body is bent

- If possible
- Or if not possible

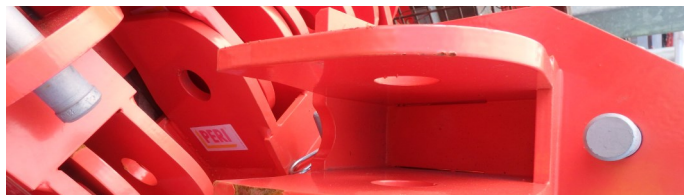
Connection lug is bent

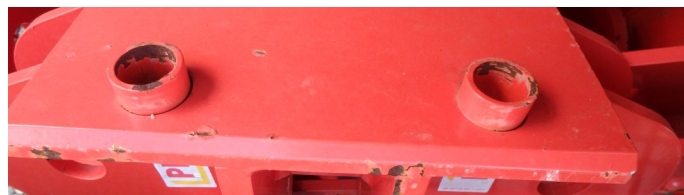
Sleeves compressed | broken

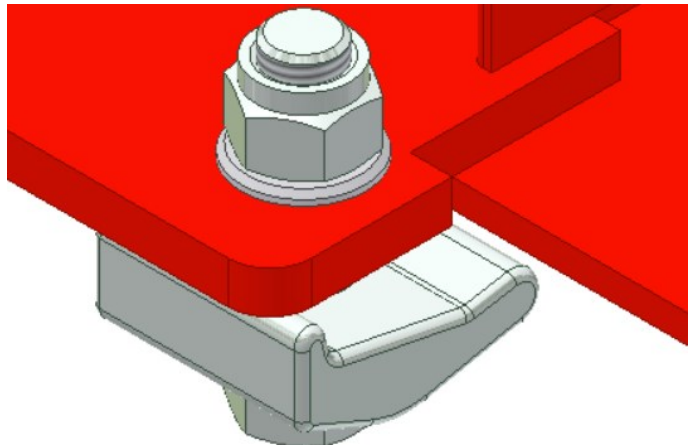
Clamping Plate Bolt Nut	<ul style="list-style-type: none"> <li data-bbox="873 566 985 598">■ Missing

<li data-bbox="873 710 1176 742">■ Or damaged due to force

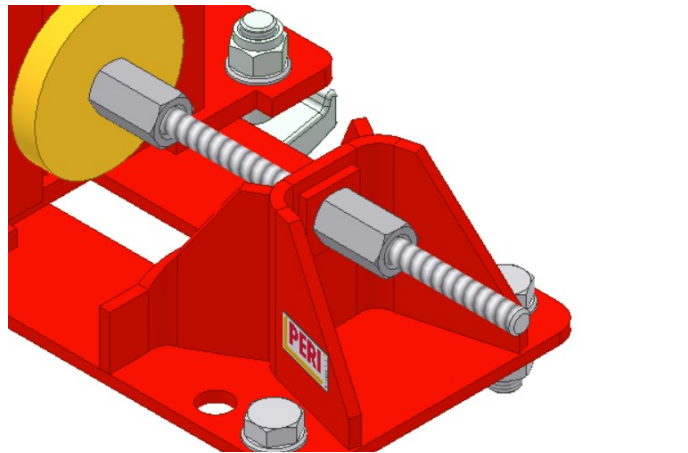
Tie Rod Nut	<ul style="list-style-type: none"> <li data-bbox="873 1085 985 1117">■ Missing

<li data-bbox="873 1228 1176 1260">■ Or damaged due to force
