PERI Rental Criteria

Slab Table Trolley

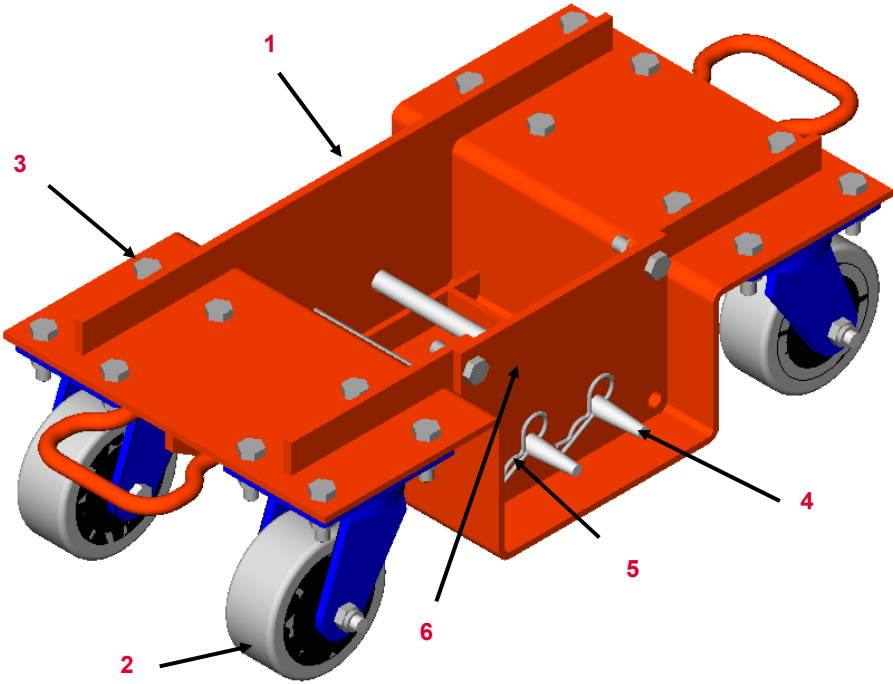
- 1 Slab Table Body
- 2 Heavy Duty Wheel
- 3 Bolt, Nut & Washer M12 x 40 mm, G8.8
- 4 Pin Ø 16 x 295, galv.
- 5 Cotter Pin Ø 4 mm
- 6 Plate

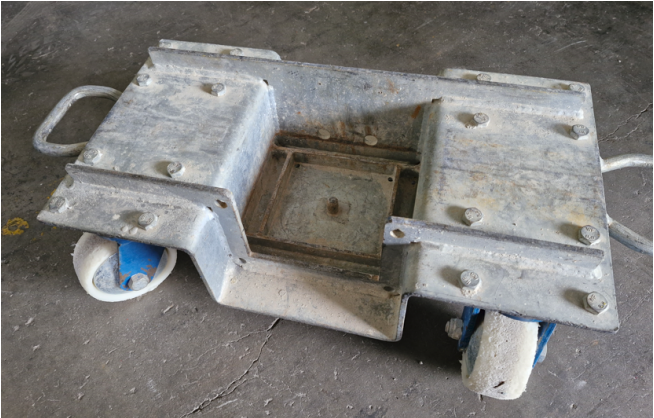
Missing Plate, Pin and cotter pin

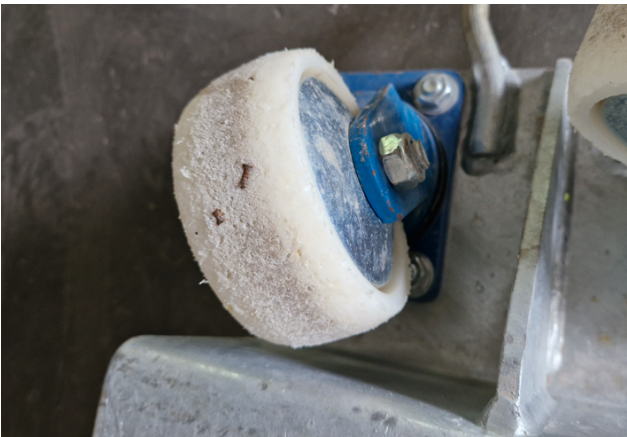
Foreign material embedded into wheel

- If possible

- Or if not possible

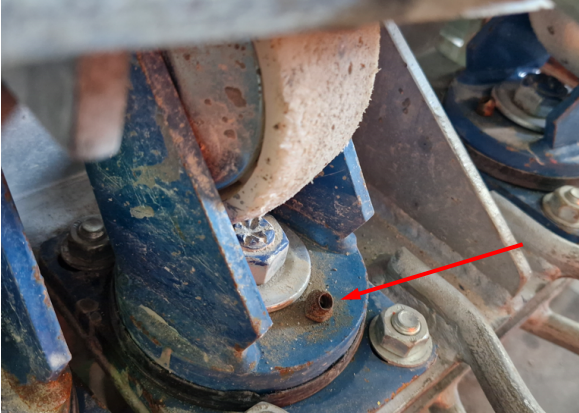
Damaged greasing nipple

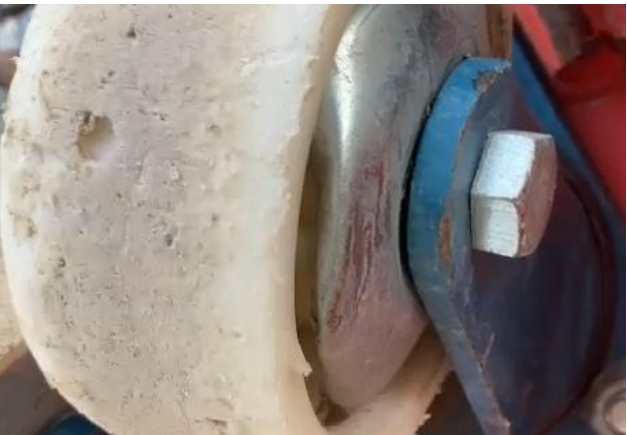
Damaged wheel (Cannot Rotate)

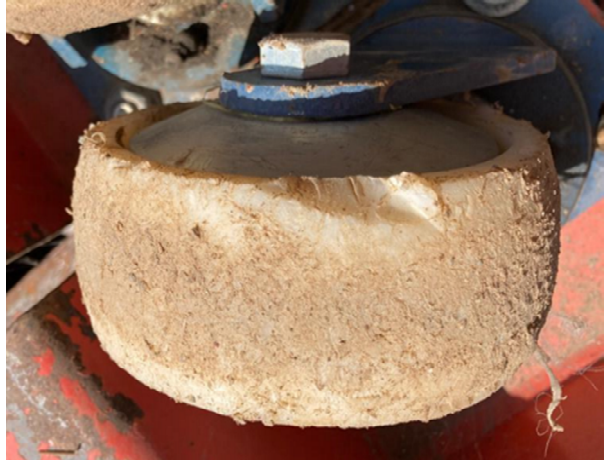
<p>Damaged Wheel (Chipped Off)</p>

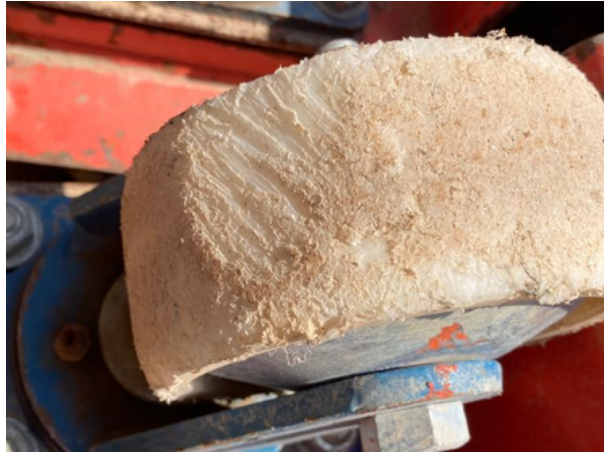
<p>Damaged Wheel (Profile damaged)</p>

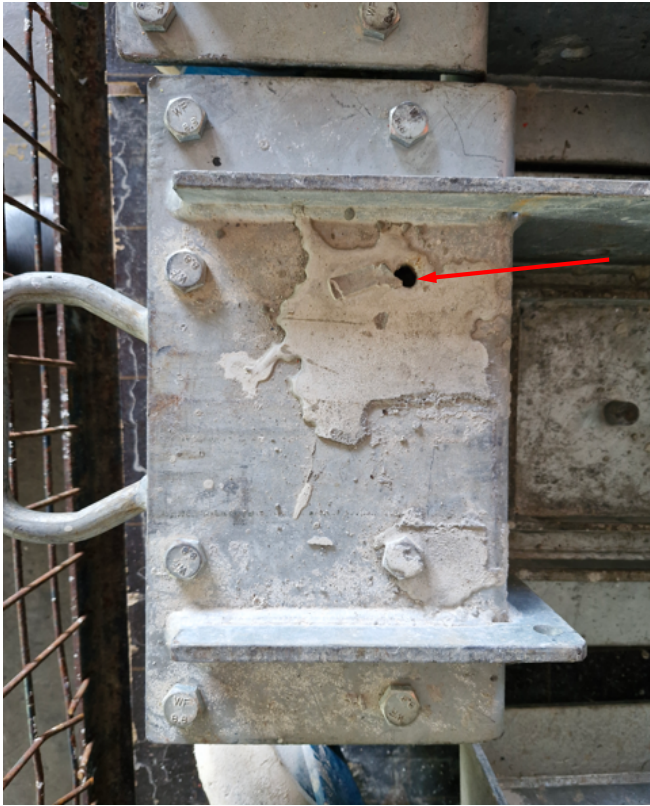
<p>Missing Bolt/Nut</p>
