# PERI Rental Criteria

## Cantilevered Parapet Bracket

Content	Page	Changes made	Date   Initial	Page
Bracket Post	2	New Version	05/19   fw	
Platform Cantilever Beam	4	Articles 134161 and 134169 added	08/19   fw	2; 17
Formwork Support	7			
Bracket Cantilever	10			
Formwork Fixing VGK- 2	13			
Formwork Post	15			
Suspension Head	18			
Brace Connector	19			
Glossary	20

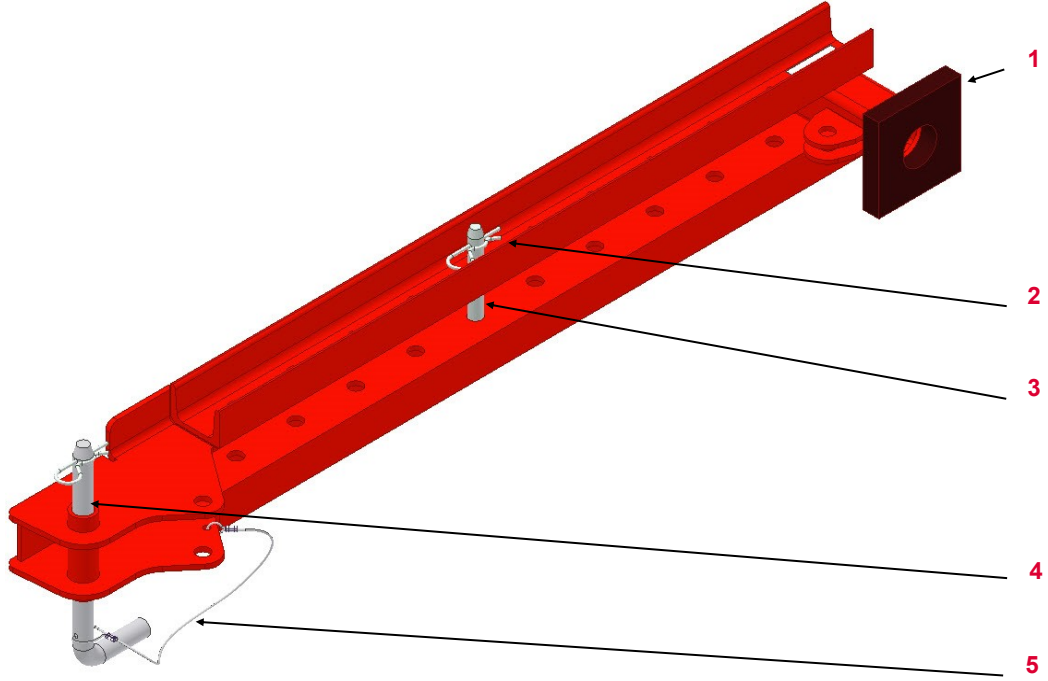
Bracket Post VGK	No.	Name	Article number
------------------	-----	------	----------------

1	Support FinPly	124396
2	Cotter Pin	018060
3	Pin D=16x90	118463
4	Pin 20x260	113012
5	Stranded Rope	127303

Valid for	
Bracket Post VGK 70	134161
Bracket Post VGK 110	124404
Bracket Post VGK 139	124427

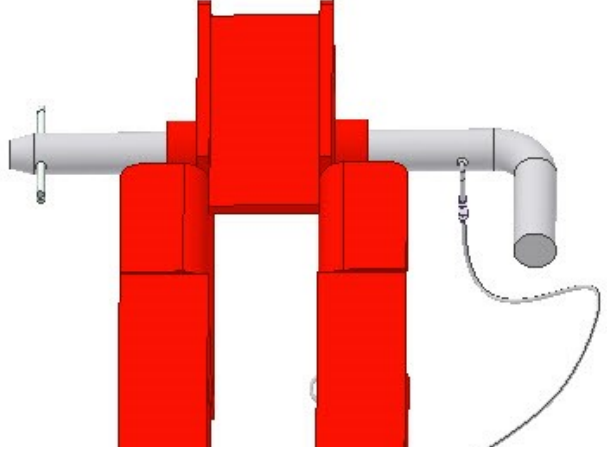
<p><b>Pin   Cotter Pin   Robe</b></p> <ul style="list-style-type: none"> <li>■ Missing</li> <li>■ Or damaged due to force</li> </ul>	<ul style="list-style-type: none"> <li>

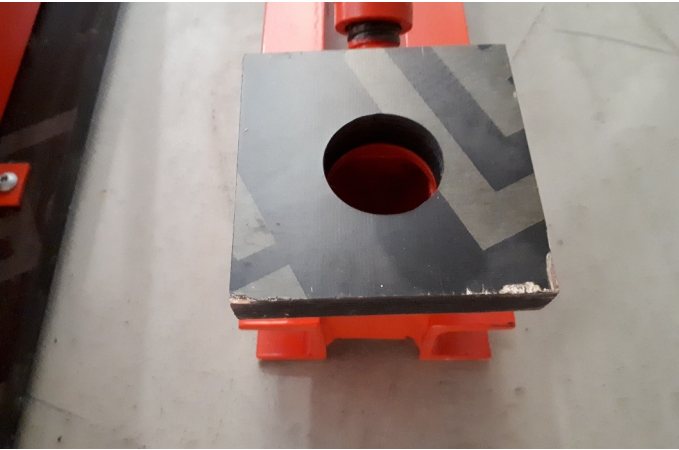
<p><b>Support FinPly</b></p> <ul style="list-style-type: none"> <li>■ Worn</li> <li>■ Or missing</li> </ul>	<ul style="list-style-type: none"> <li>

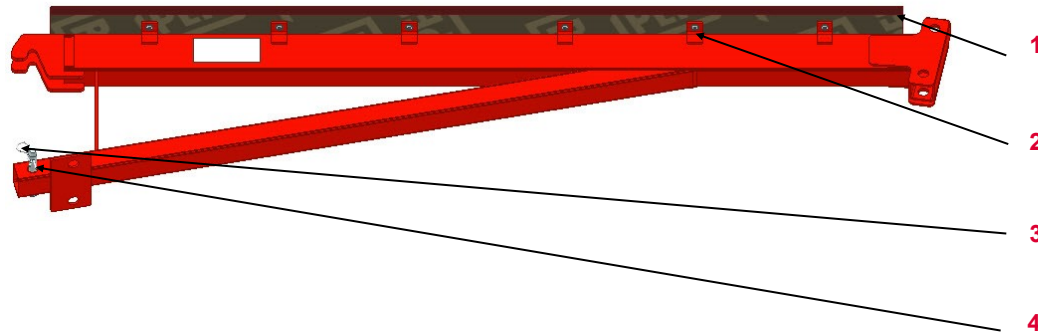
### Platform Cantilever Beam VGK 170 (124447)

No.	Name	Article number
1	Nail Board	124428
2	Spax 8x20	024550
3	Cotter Pin	018060
4	Pin 16x90	118463

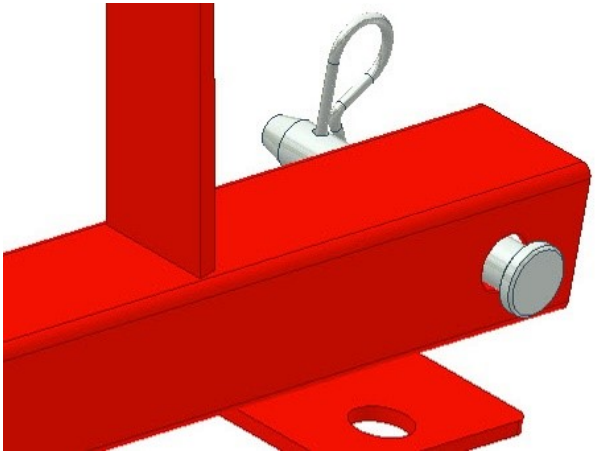
Pin | Cotter Pin missing

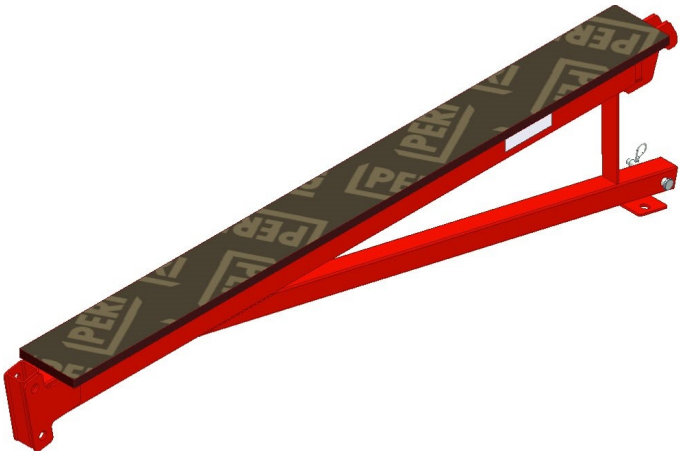
Nail Board Worn

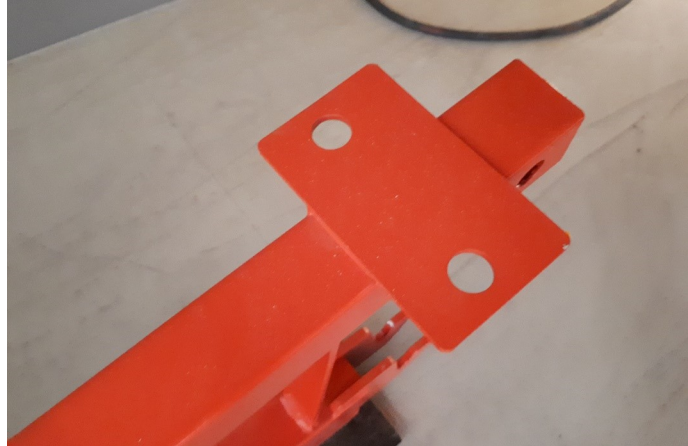
<p><b>Plates bent</b></p> <ul style="list-style-type: none"> <li>■ If possible</li> <li>■ Or if not possible</li> </ul>	<ul style="list-style-type: none"> <li>

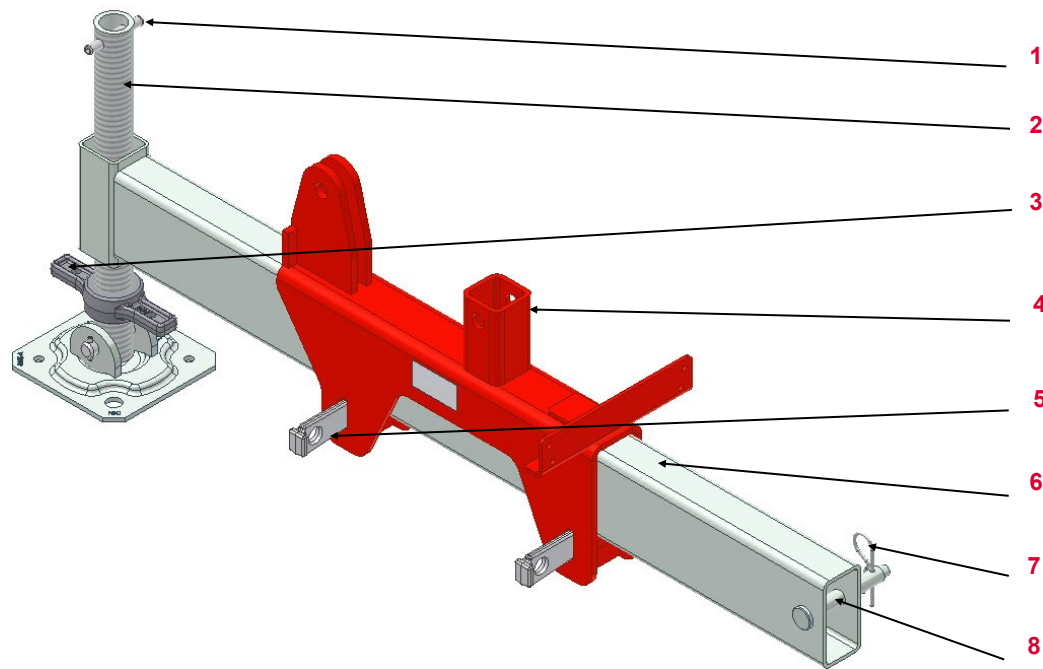
Formwork Support VGK (124438)	No.	Name	Article number
-------------------------------	-----	------	----------------

1	Sleeve	105365
2	Articulated Base Spindle	124419
3	Wing Nut	710071
4	Guide Carriage	124434
5	Wedge	024250
6	Formwork Guide	124435
7	Cotter Pin	018060
8	Pin 16x90	118463

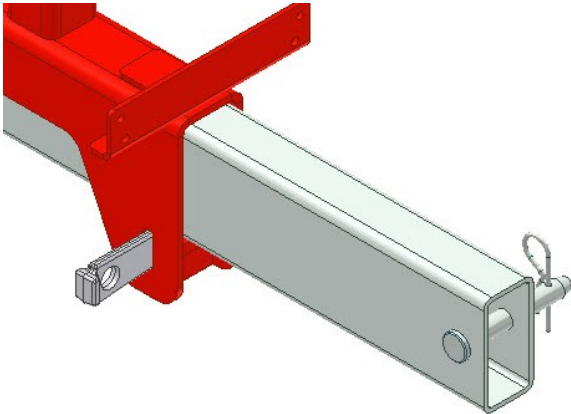
Bolt | Pin | Cotter Pin missing

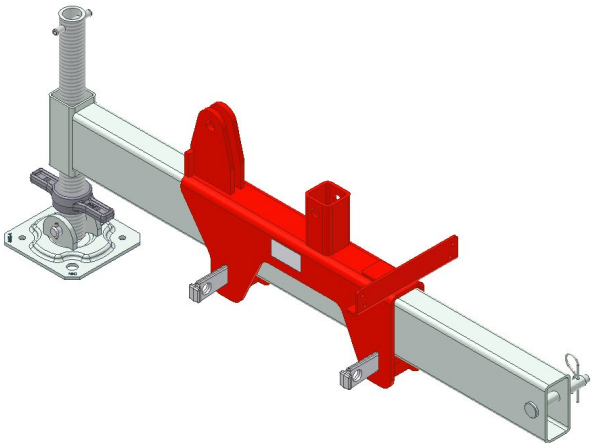
Parts bent

■ If possible

■ Or if not possible

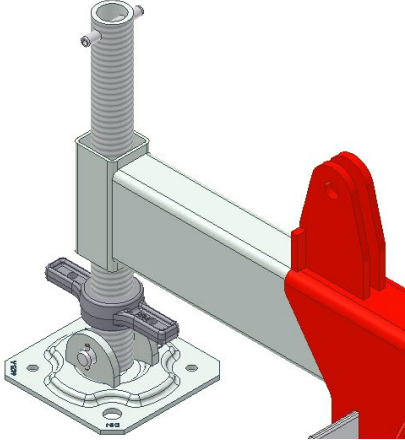
<p><b>Function of spindle not given</b></p> <ul style="list-style-type: none"> <li>■ Due to weariness</li> </ul>

<ul style="list-style-type: none"> <li>■ Or damaged due to force</li> </ul>

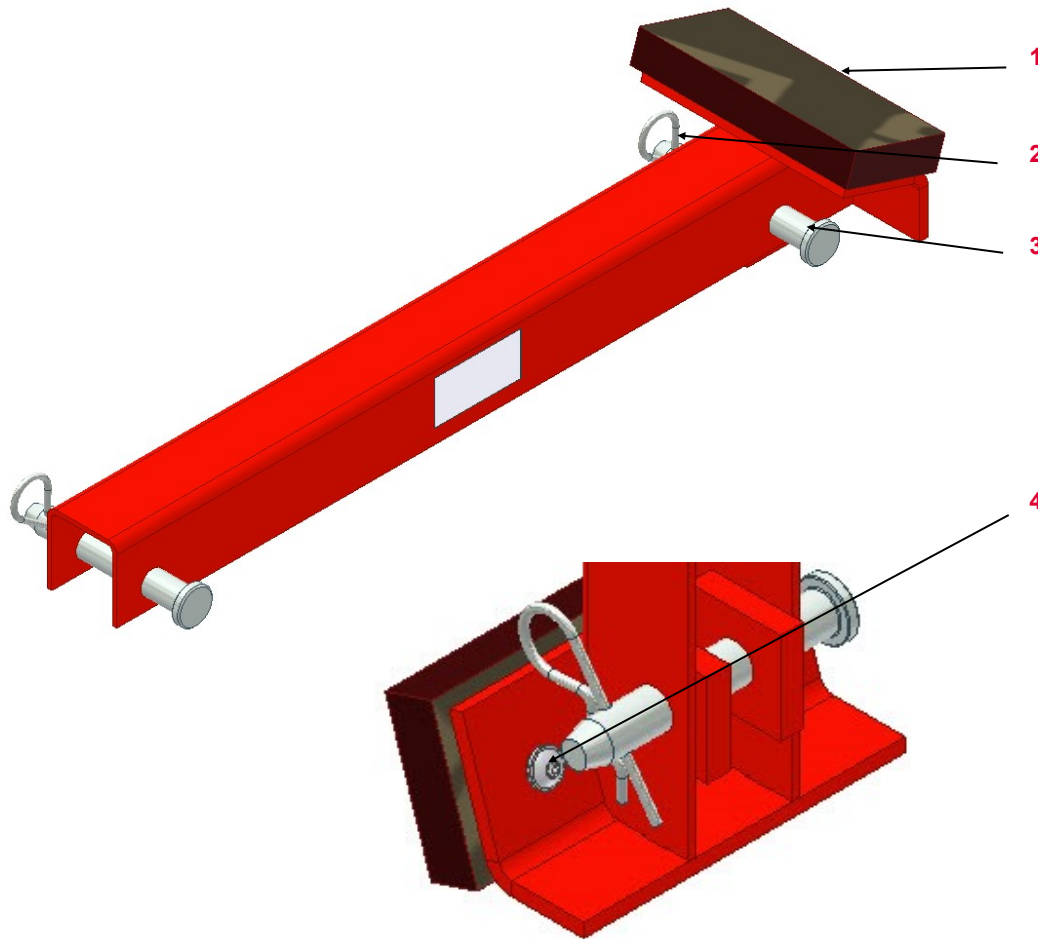
### Bracket Cantilever VGK 50 (124455)

1	Formlining	124449
2	Cotter Pin	018060
3	Pin 16x90	118463
4	Spax 8x20	024550

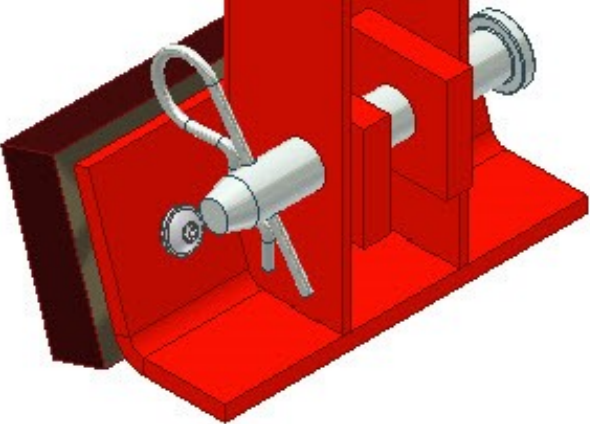
<p>Bolt   Cotter Pin missing</p>

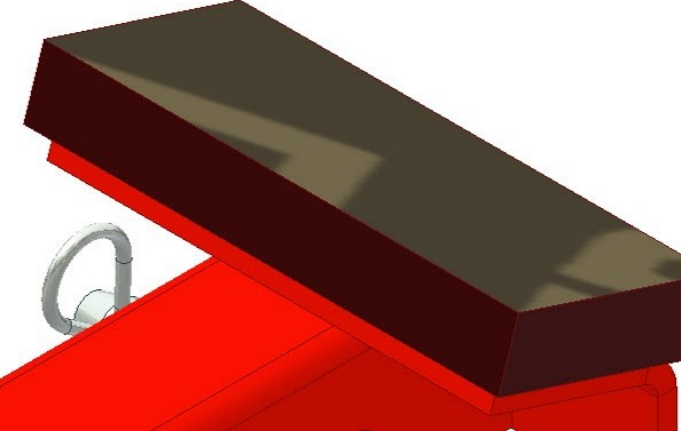
<p><b>Formlining</b></p> <ul style="list-style-type: none"> <li>■ Missing</li> <li>■ Or worn</li> </ul>

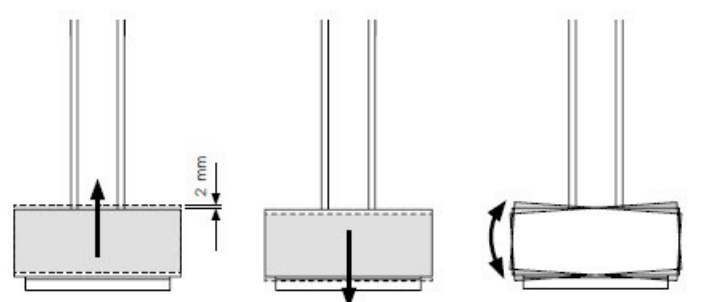
<p><b>Function of Formlining</b></p> <ul style="list-style-type: none"> <li>■ Formlining moveable—approx. 2 mm forwards, back and twistable</li> <li>■ Or if not moveable</li> <li>■ Or sealing damaged</li> </ul>	<ul style="list-style-type: none"> <li>✓</li> <li>⚙</li> <li>⚙</li> </ul>	<ul style="list-style-type: none"> <li>🚫</li> <li>🔧</li> <li>🔧</li> </ul>	<ul style="list-style-type: none"> <li>⚙</li> <li>⚙</li> <li>⚙</li> </ul>

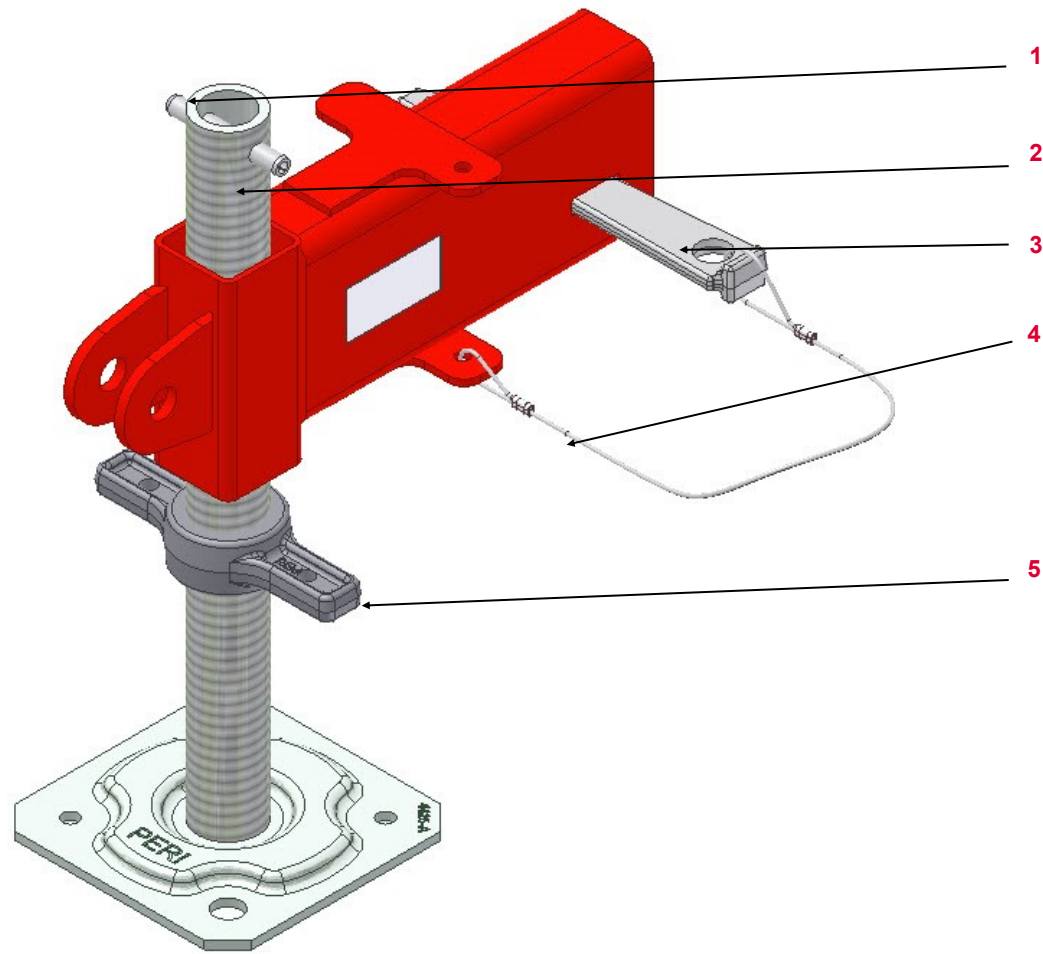
Formwork Fixing VGK 2 (124394)	No.	Name	Article number
--------------------------------	-----	------	----------------

1	Sleeve	722457
2	Base Spindle	124380
3	Wedge	024250
4	Robe	127303
5	Wing Nut	710071

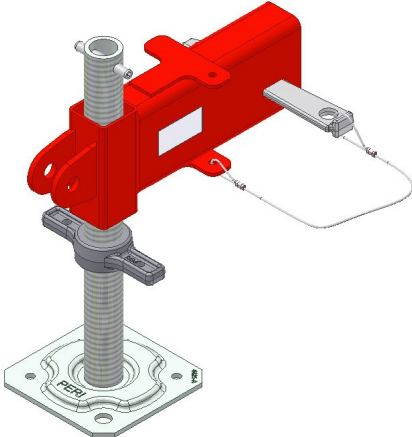
<p><b>Parts</b></p>			
	<ul style="list-style-type: none"> <li>■ Missing</li> </ul>

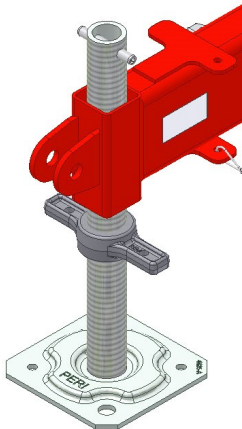
<p><b>Function of Base Spindle not given</b></p>			
	<ul style="list-style-type: none"> <li>■ Damaged due to force</li> </ul>

<ul style="list-style-type: none"> <li>■ Or due to weariness</li> </ul>

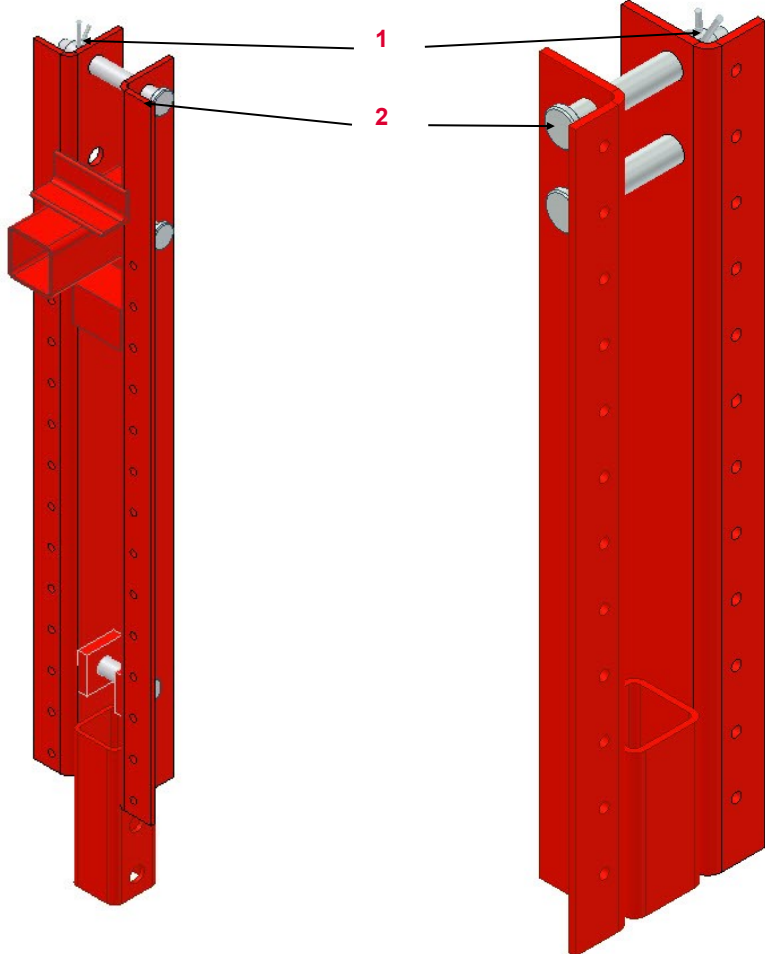
Formwork Post (124371)   Formwork Post Extension (124360)	No.	Name	Article number
---	-----	------	----------------

1	Cotter Pin	018060
2	Pin 16x90	118463

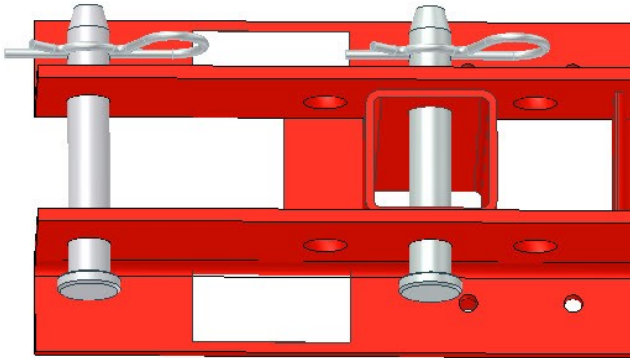
<p><b>Pin   Cotter Pin missing</b></p>

<p><b>Bent</b></p> <ul style="list-style-type: none"> <li>■ If possible</li> <li>■ Or if not possible</li> </ul>	<p>■ If possible</p>

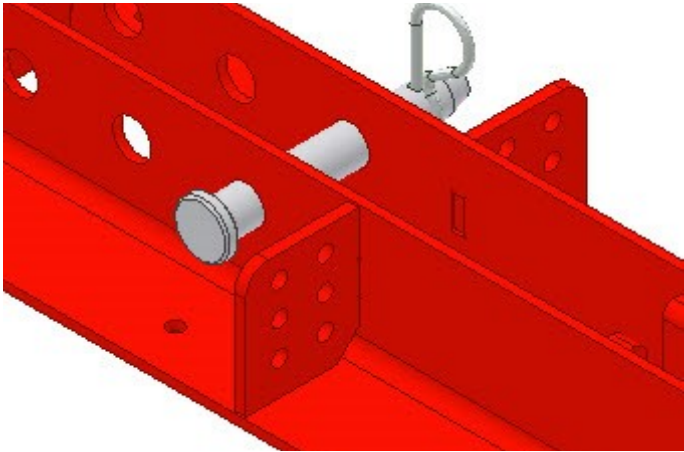
Pin | Cotter Pin missing

118463 (Pin)  
018060 (Cotter Pin)

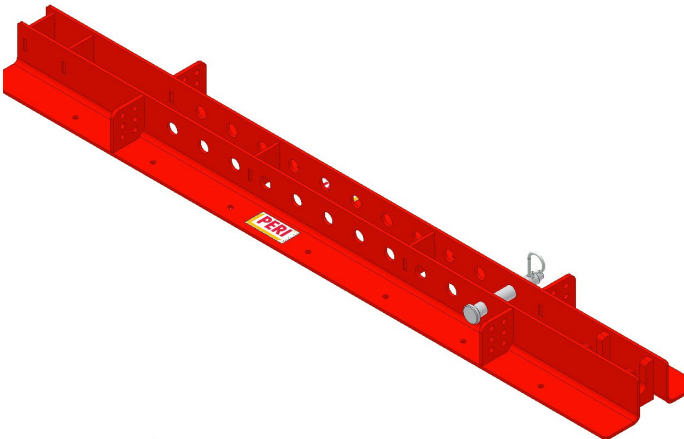
**Bent**

- If possible

- Or if not possible

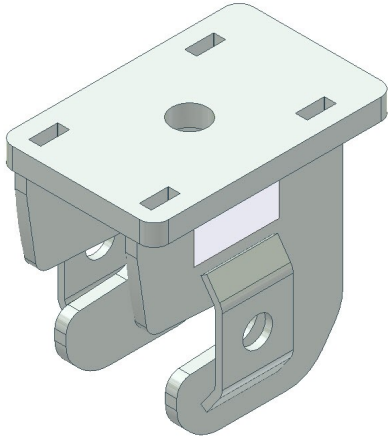
<b>Bent</b>			
	<ul style="list-style-type: none"> <li>■ If possible</li> </ul>

<ul style="list-style-type: none"> <li>■ Or if not possible</li> </ul>

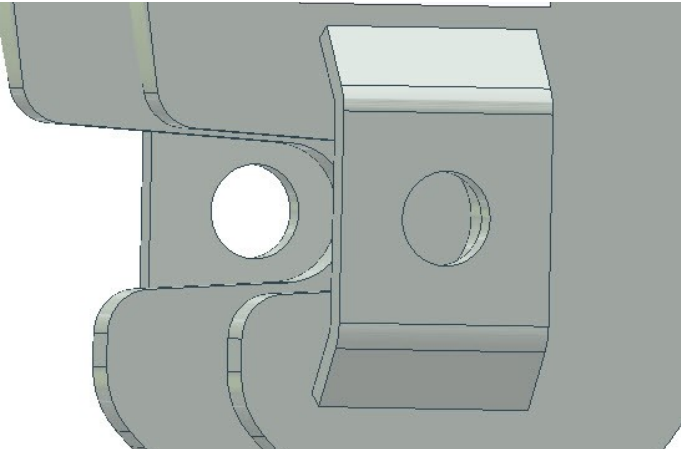
<b>Geometry of drill holes</b>			
	<ul style="list-style-type: none"> <li>■ Original geometry given</li> </ul>

<ul style="list-style-type: none"> <li>■ Or if not given</li> </ul>

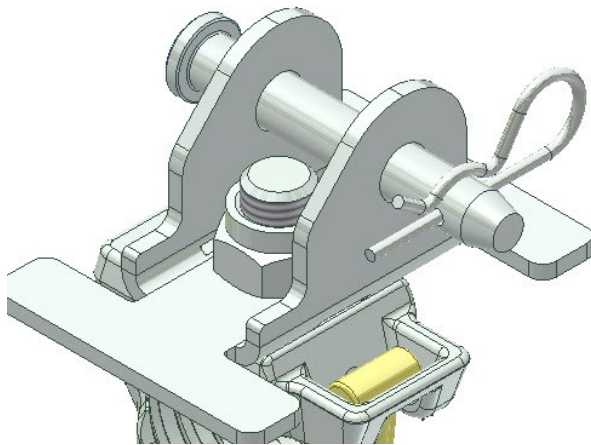
<p><b>Pin   Cotter Pin missing</b></p>

<p>710222 (Pin 16x90) 018060 (Cotter Pin)</p>

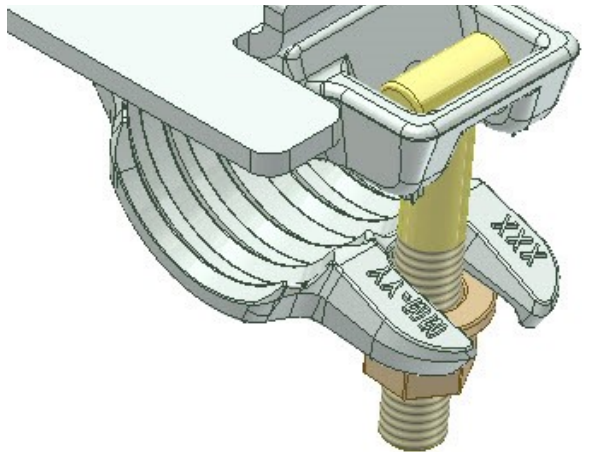
<p><b>Hammer Head Bolt   Nut missing</b></p>

<p>710340 (Nut) 131316 (Hammer Head Bolt)</p>
